Accident C-130H Hercules

Airbase Eindhoven, the Netherlands
15 July 1996

by
Harry Horlings
AvioConsult

The turn of conclusions

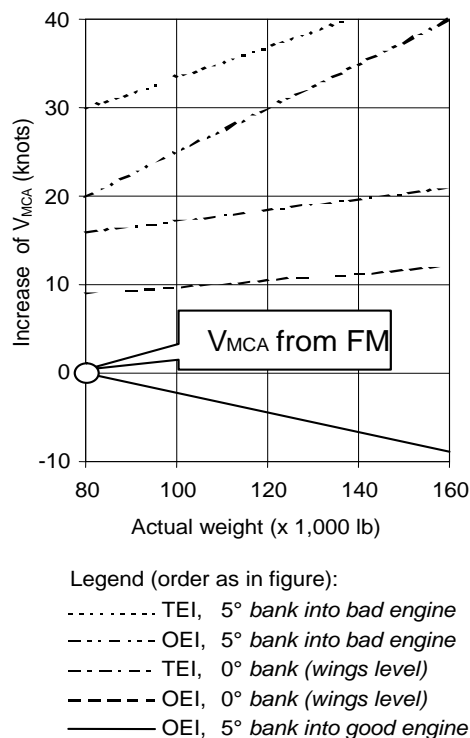
Figure 1. Effect of bank angle and weight on V_{MCA}

5.10. In the same chapter under Turns: *Turns into inoperative engine(s) are not recommended due to the increase in V_{MCA} encountered when the 5-degree favorable bank angle (into the operative engines) is reduced.* The effect of bank angle and weight on V_{MCA} is illustrated in Figure 1 on page 12.

Then only aerodynamic control is available for which the airspeed needs to be high enough. If not a bank angle of 5 degrees is maintained away from the inoperative engine, V_{MCA} is at least 10 kt higher than the V_{MCA} that is listed in the Performance Manual (Figure 1 below).

7.4. If engine #3 was shut down and the remaining engines were all generating maximum thrust for the go-around, then the minimum control speed to be observed was 103 kt, provided the other conditions, such as a 5 degrees bank angle away from the failed engine (in this case to the left), are complied with. If however the wings are maintained level, then the actual V_{MCA} at 98,000 lb gross weight is nearly 10 kt higher than the V_{MCA} that is listed in the Performance Manual (see Figure 1 below). Then the minimum control speed is $103 + 10 = 113$ kt, instead of 103 kt. Because engine #3 is an in-

board engine on the less critical right hand side, the actual V_{MCA} was most probably lower (safer), and almost equal to the touchdown speed (97 kt). The airspeed was indeed not much lower than the actual V_{MCA} , which can be concluded from the very slow increase of banking to the left and the path that the airplane flew in the 12 seconds after the bird hit.
