FINAL REPORT

requested by judgment of the 8th of July 2015
issued by the HAGUE DISTRICT COURT
(Chamber of Commercial Affairs)

Accident occurring in FARO Airport – Portugal
21st of December 1992

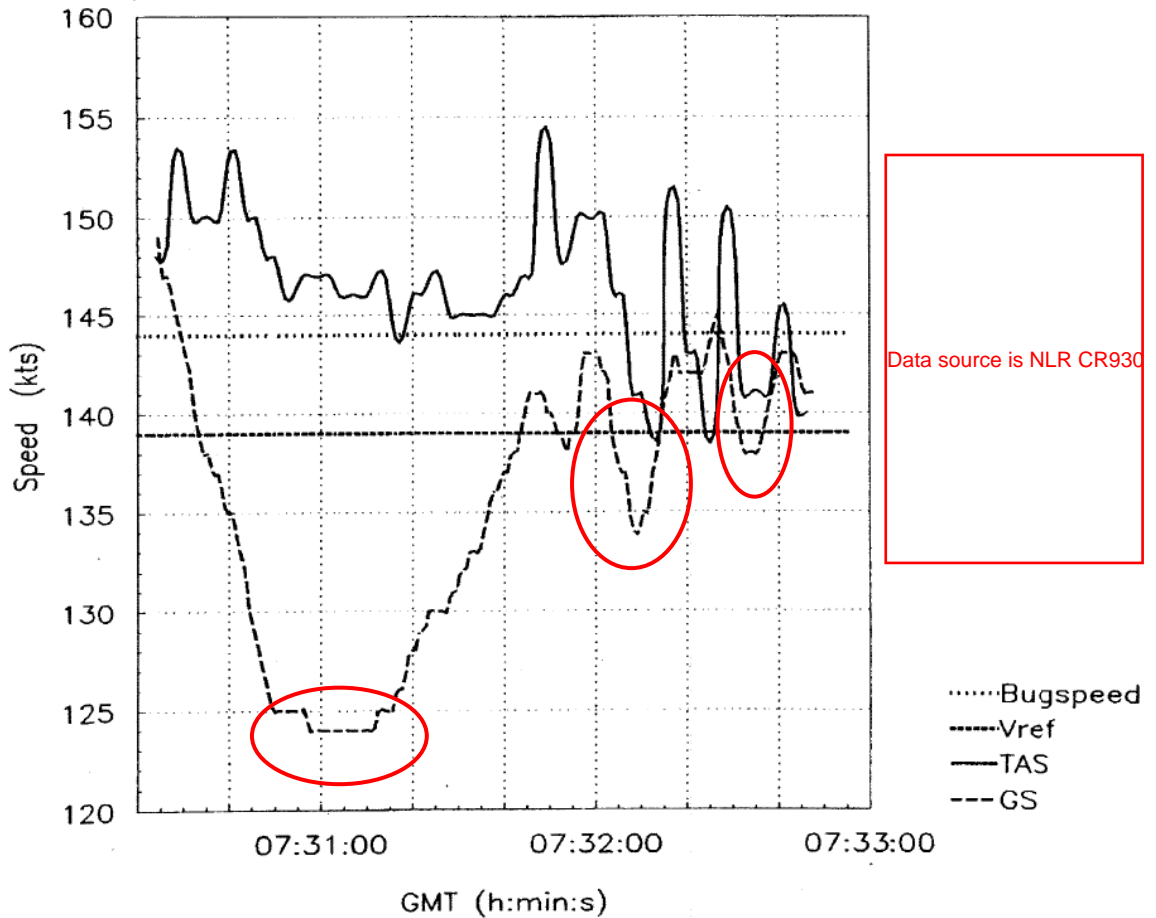
Fig. 4 Groundspeed and True Airspeed time history

One of the most obvious reasons for the NLR to conclude to the presence of three windshear situations is the change in ground speed as indicated in the diagram above¹³².

Where is the ground speed data from? How calculated? Reliable data? Have you noticed the changes required by DASB?

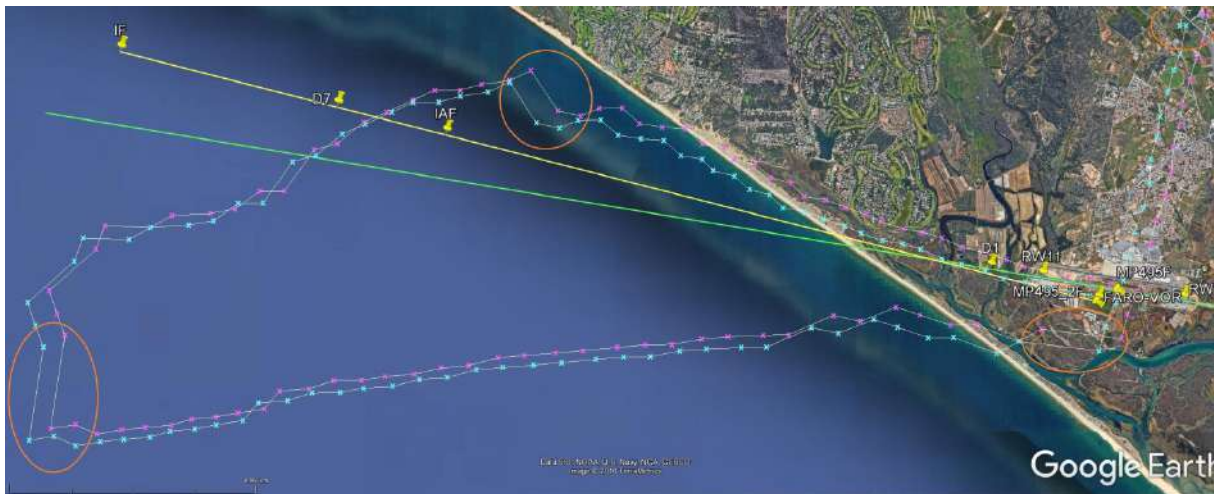
Figure 1: Lateral Flight Profile based on radar data (in Google Earth projection) (Magenta: Original radar track; Cyan: Corrected radar track)

What radar data?

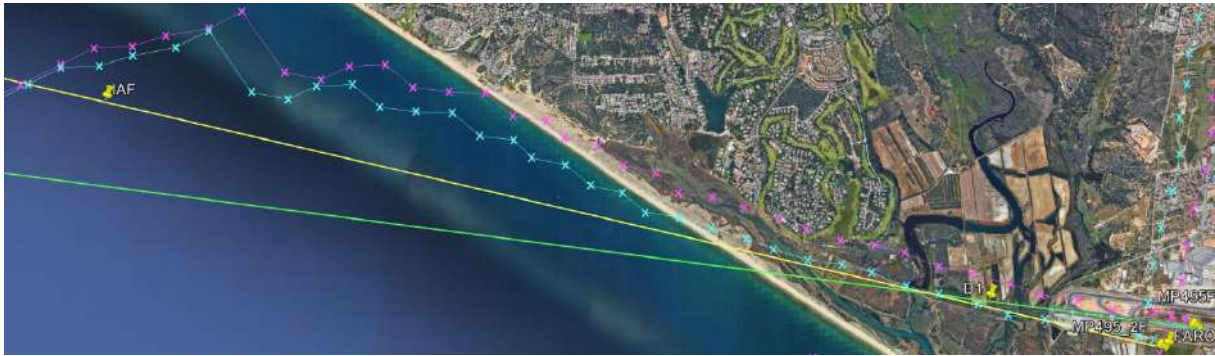
Figure 2: Lateral Flight Profile based on radar data (from IAF to touchdown, zoomed in Google Earth projection) (Magenta: Original radar track; Cyan: Corrected radar track)

Corrected? How, why?

The corrected radar data track (cyan colour) ends up about 150 [m] south of and about 900 [m] from the threshold of runway 11 (see orange circle). The original radar track data (magenta colour) ends up about 90 [m] north of and about 1.200 [m] from the threshold of runway 11 (see orange circle).

"Good data" isn't it? No!

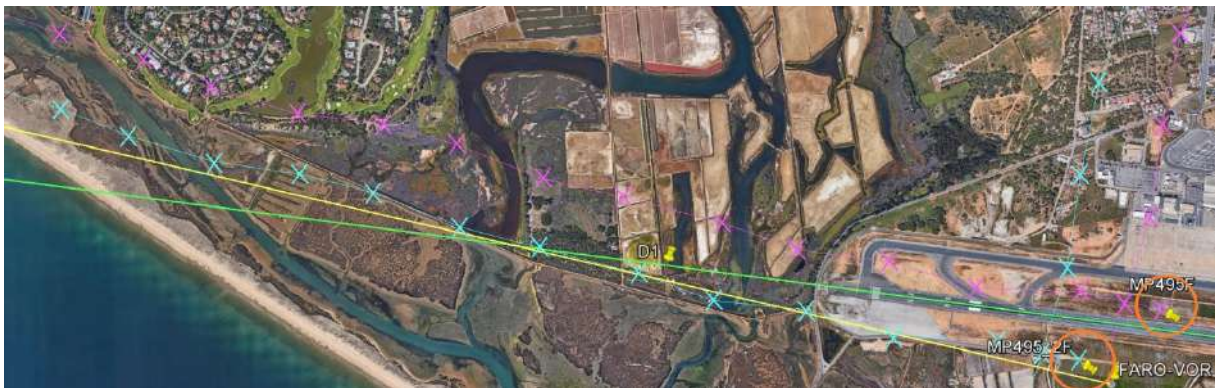
Figure 3: Lateral Flight Profile based on radar data (final segment, zoomed in Google Earth projection) (Magenta: Original radar track; Cyan: Corrected radar track)

As the aircraft has reached the runway 11 (around 350 m to 400 m beyond runway threshold) it can be assumed that the last radar datum should be somewhere around this position. It has therefore been assumed that the corrected ("cyan") radar track (corrected by NAV Portugal) is the most "suitable" radar track; this corrected "cyan" track is identical in principle with the "magenta" track but shifted by a lateral correction factor.

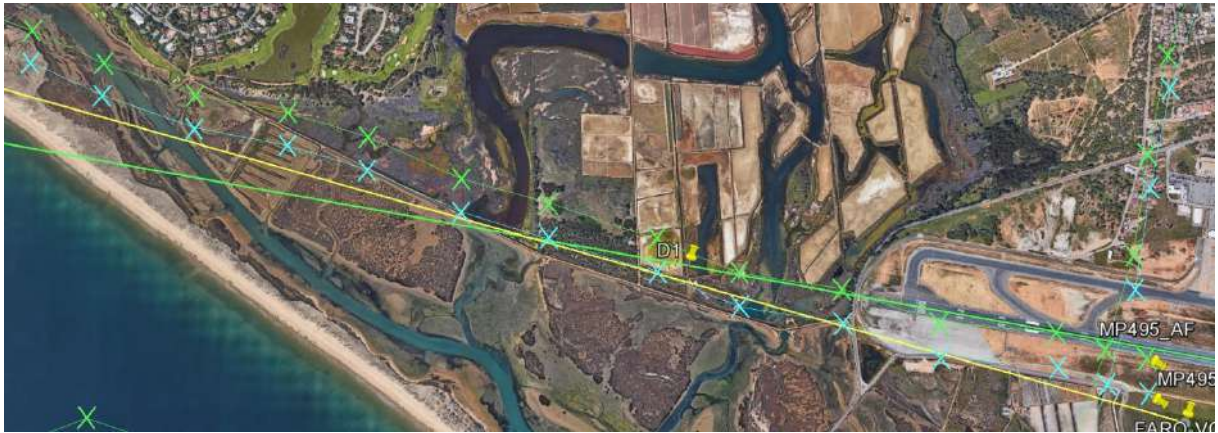
Figure 4: Lateral Flight Profile based on radar data (final segment, zoomed in Google Earth projection) (Cyan: Corrected radar track; Green: Shifted corrected radar track)

In a next step the green track has been again shifted to the west end of the runway (to become a “purple” track) so that the last radar datum (see orange circle in figure 5) is in point of flight MP495.

Experts shift data? Objective?

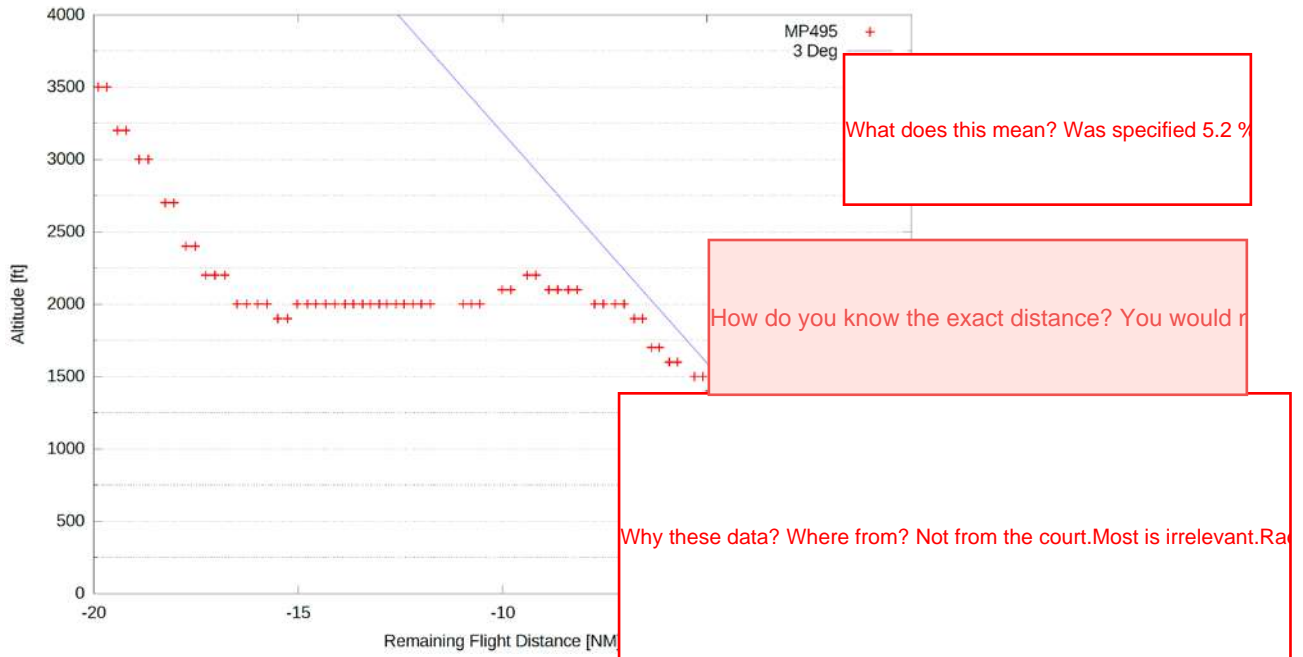
Figure 8: Vertical Flight Profile based on radar data

Then why and how did the airpl

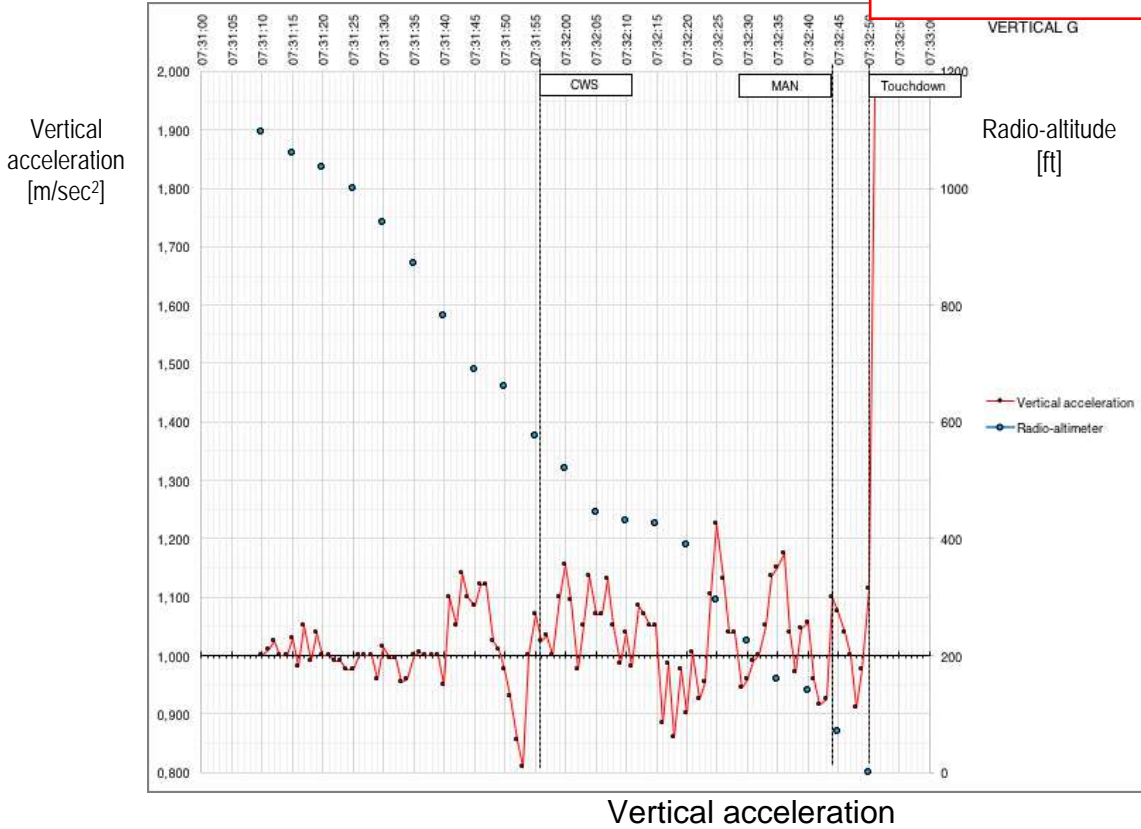
8.6.5.3.1. THE VERTICAL ACCELERATION

Is not DFDR data out of RvO Annex 15, is it? Why not

To analyze the actual acceleration, the aircraft, sustain^{ed} during this final approach, we must take into account the instantaneous bank angle because this angle creates a centrifugal

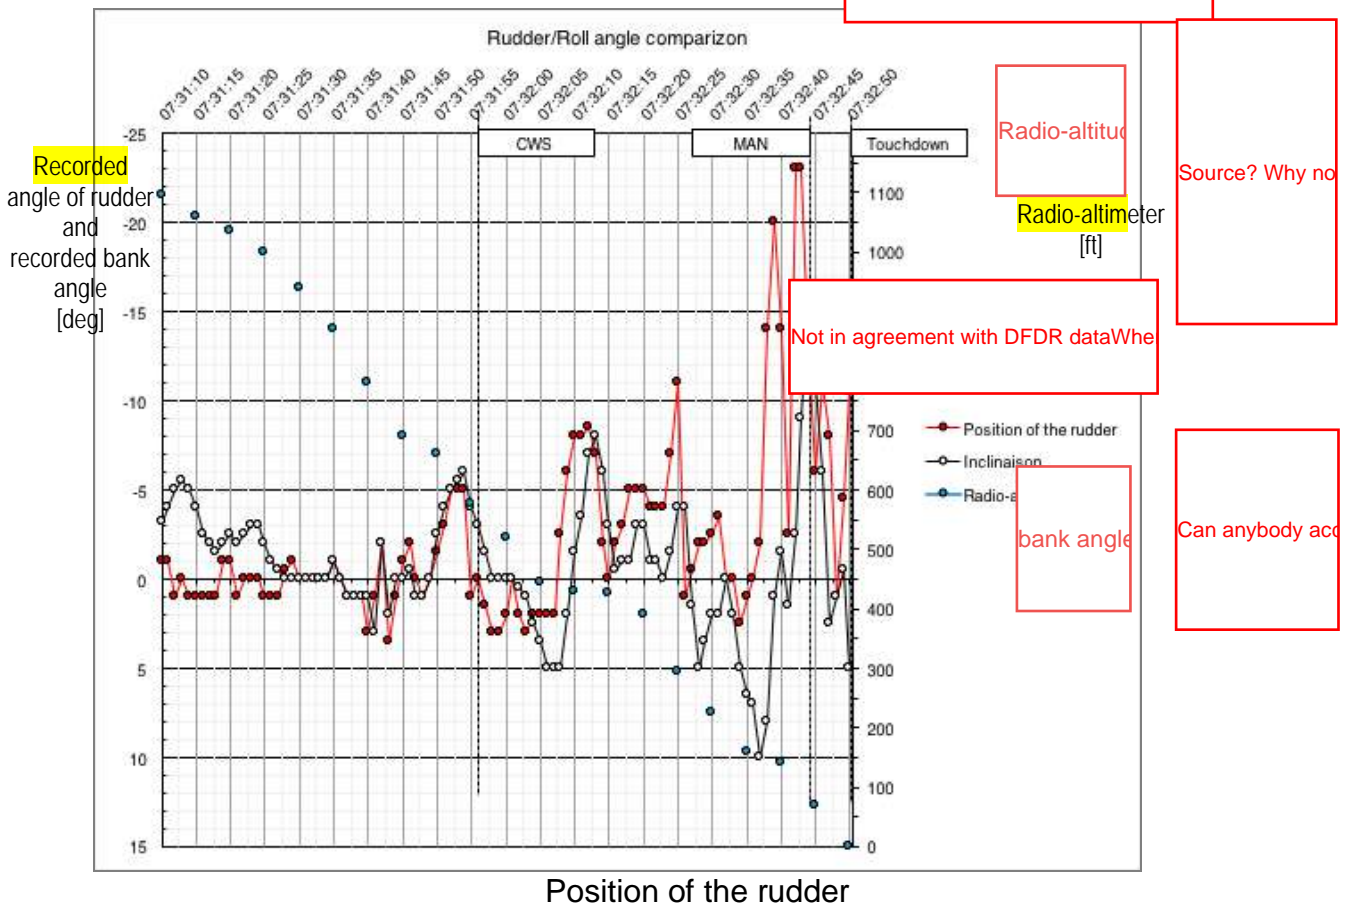
8.6.5.3.2.1. THE RUDDER¹⁴⁹

?? Roll management with rudder data?

Source? Why no

Not in agreement with DFDR data

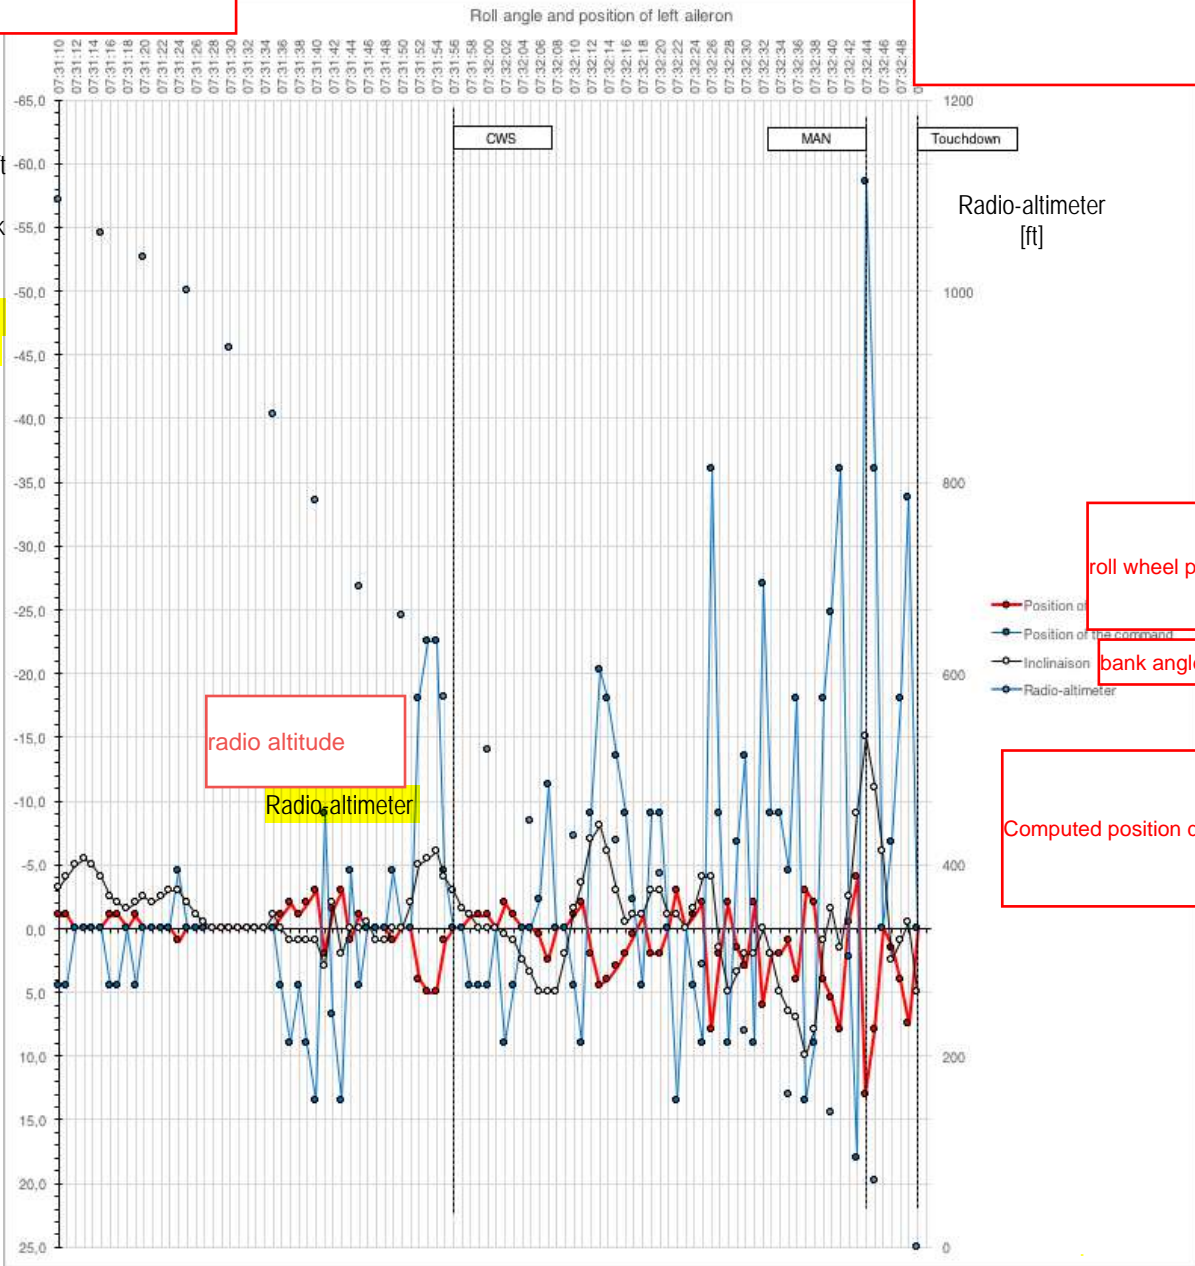
Recorded angle of the left aileron,
Recorded bank angle
Calculated position of the control wheel [deg]

What is the data source? One data point even

roll wheel position or roll

bank angle?
