## Critical Review of NLR Reports CR 93080 C and CR 94238 C, both on the Analysis of the DC-10 crash at Faro Airport, 21 Dec. 1992

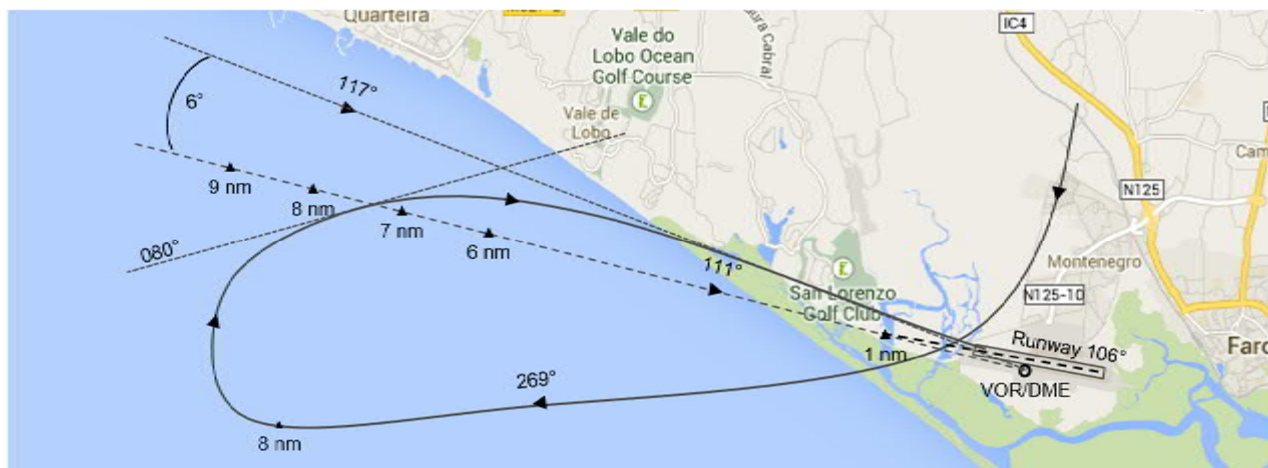
3. In accordance with the Approach Chart issued by the Portuguese authorities, the final approach begins at  $2000\text{ft}$  altitude at  $6.5\text{nm}$  distance from and on a radial of  $111^\circ$  to the VOR/DME in the Command (CMD) mode of the autopilot that is set at a constant vertical speed, usually  $750\text{ft/min}$ . The  $5^\circ$  lateral offset from

the runway bearing 106° is due to the location of the VOR/DME south of the runway. At 1 nm in front of the runway threshold, the 111 radial intersects with the extended runway centerline, at which point the airplane has to turn 5° left from the offset 111° VOR/DME approach radial to the runway bearing of 106°.

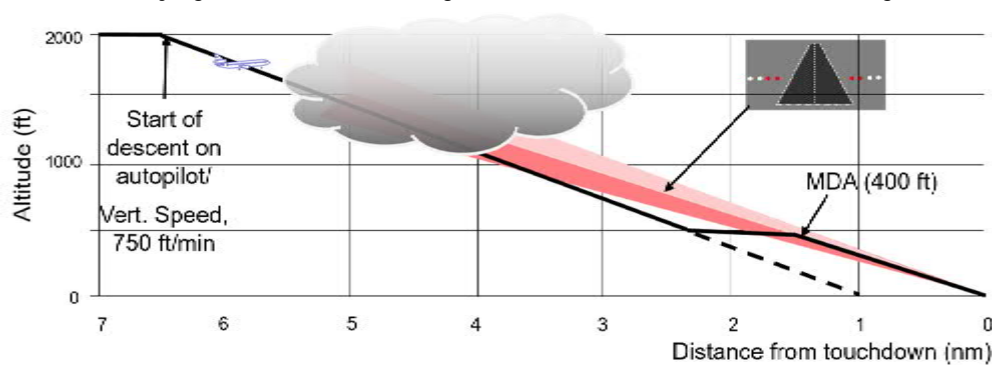
the initial final descent from 2000 ft was set a little too high, because the head wind component might have been larger than anticipated, the airplane reaches 500 ft earlier, below the PAPI glidepath, requiring

straight and level flight until the PAPI indicated glide path (5.2%) can be intercepted. This is what happened to MP495, but is normal to this procedure and is shown in the adjacent figure.

5. NLR however, explained the 10 s level flight of MP495 at 500 ft for intercepting the PAPI indicated glidepath as "*the updraft of the downburst*" (CR 94238 C pages 21 and 26), but it was just part of the normal approach procedure to intercept the PAPI indicated glidepath from below before reaching the Minimum Decision Altitude of 400 ft. NLR engineers concluded up- and downdrafts during the approach, but were obviously not (made) aware of glide path discontinuities that are not uncommon during non-precision approach procedures.

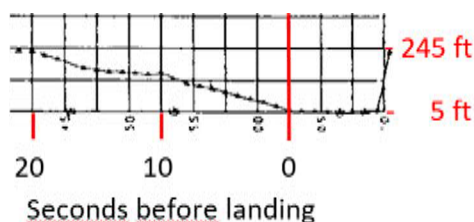
17. The 'sink rate' (usually called rate of descent - ROD) during final approach changed from 760 ft/min in the draft of this report (CR 94xxx), to an 'inertial' 966 ft/min in the final version. Fig. 17 shows a change of vertical speed in 2 s from +625 to -2625 ft/min just prior to touchdown. This is not realistic for a 161.400 kg body on a 5.2% glide slope at a low altitude. Objective DFDR Radio altitude data does not confirm this either, see adjacent figure. DFDR data should have been used, rather than such unreliable calculated data.
