The Last 80 Seconds of Flight MP495 on Dec 21, 1992

DFDR and AIDS data analyzed in detail

3 August 2017

AvioConsult

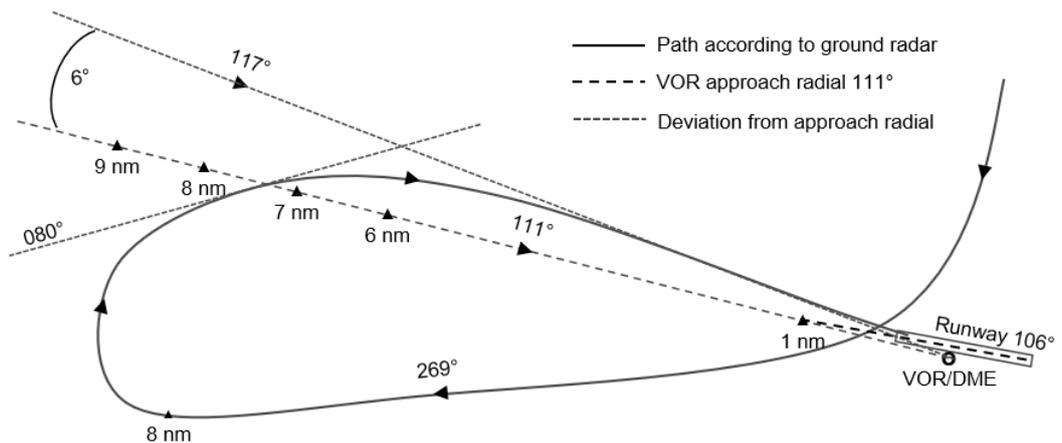
Figure 1. Approach to airport Faro according to Portuguese ATC radar.

This could have happened with MP495, because the ATC radar data in Figure 1 on page 9 shows a near constant (too) large deviation (6°) from the prescribed approach radial, in which case 117° would have been set as direct to radial. At 3 nm, the HSI indications would have been as shown in the adjacent figure. The heading was 125° (DFDR data), the approach radial set to 117°. This angle was measured in the radar plot in Annex 12 of the RoA, that is copied in Figure 1.

- 5.6.2. **At 500 ft**, the airplane should have flown within 2° of the 111° approach radial for the approach to be allowed to continue; in BIM 3.3.4 – 06 this lateral limit is considered essential. The deviation was much larger (Figure 1) hence, for this reason a go-around should already have been initiated at this time. BIM 3.4.4 – 06 procedures leave no doubt about this, and neither about "basic stability of speed and thrust": "On short or wet runways such factors become of paramount importance. It is therefore strongly recommended that no landing be attempted if the desired stabilization has not yet been achieved when passing 500 ft above threshold elevation". In the same BIM paragraph, approach stability is defined as follows: "Early stabilization on the final approach path with respect to glide path and centre line [$<2^\circ$, RoA § 2.2.3] is considered essential. At not less than 500 ft above threshold elevation this flight path stabilization must also be accompanied by a basic stability of speed and thrust, thus ensuring that any disturbing influences or deviations in the latter stage of the approach can be readily recognized and rapidly corrected".

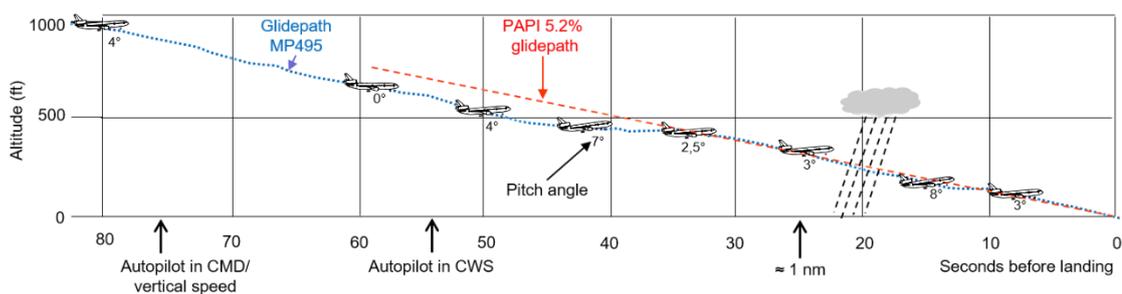
Figure 5. Vertical profile approach MP495, initially in Vertical Speed command mode, from 54 s in CWS. DFDR data.

5.5.2. The DFDR data shows that from 52 s the elevator control input caused the pitch angle to increase from 0° in 10 s time, with a small variation (Attachment 1 ⑧ and Figure 5). At that instant, the copilot obviously saw both the runway and more red than white PAPI lights and realized that he was below the PAPI glide path (Figure 3 and Figure 5 above). The airplane then maintained level flight for about 12 s (Attachments 1 ⑨ and 4 ⑤) to intercept the PAPI glide path, which occurred at 37 s, after which the nose was pushed down to a pitch angle of 2.5° (Attachment 1 ⑩). The copilot even said "PAPI hè" (CVR transcript) to justify the level flight. Until this time, this is normal procedure. The 'maneuver' is the consequence of the

NLR, in RoA Annex 4, explained the maneuver as crossing an area with downdraft, followed by updraft, which was not contradicted by the (pilots of the) DSB. Objective DFDR data however, do not support up- and or downdrafts or windshear; no changes in the light turbulence (Attachment 1 (11)), no lateral accelerations (Attachment 1 (12)), and no sudden in- or decreases of airspeed caused by changes of the wind either, but only small pitch and airspeed changes due to the copilots' control inputs and the 5 kt gust protection by the autothrottle (Attachment 1 (7)).

- 5.5.3. **Sub conclusion.** Maintaining level flight for a number of seconds during the non-precision approach, being the only approach option, to airport Faro is quite normal and the consequence of the transition of the descent with a constant vertical speed, in the Vertical Speed mode of the autopilot, to the final approach flown manually supported by the CWS mode of the autopilot, while using the visual approach guidance of the PAPI. This short level flight is definitely not caused by up- or downdrafts as concluded by the NLR and not refuted by the DSB.

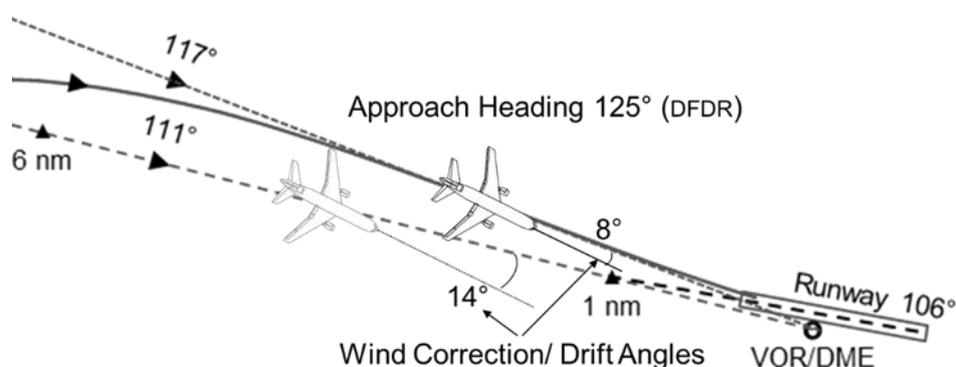
Figure 6. Comparison approach heading 125° (DFDR data) on approach radials 111° and 117° with accompanying drift angles.

- 5.6.4. The magnetic heading was 125° (until 40 s before landing when the pilot-induced side-slips started). The heading of 125° was 14° larger than the 111° VOR approach radial, which is a ground course, as DFDR data shows (Attachment 1 (13)), see also Figure 6 below. A drift angle of 14°, while the airspeed is 139 kt, is quite large and could only be caused by a crosswind component of 34 kt ($139 \cdot \sin 14^\circ$), which is larger than the 30 kt crosswind limit for a landing with a DC-10 on a dry runway (AOM 3.7.1 – 06, see also

§ 3.2.1). In addition, an experienced pilot knows the forward view during a crosswind approach; a runway is never that far left in the windscreen.

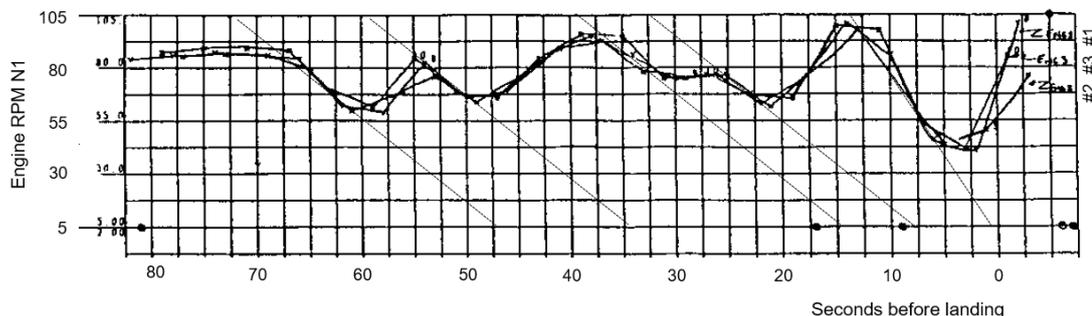
Figure 7. Comparison RPM decrease by autothrottle (4x) and manually by the copilot (1x); this last rate of decrease is larger (DFDR-data, Attachment 1).

- 5.11.1. **At 13 s**, at an altitude of 150 ft, the copilot pulled the throttle handles back to flight idle, with some force against the engaged autothrottles (Figure 7 below). Just prior to this moment, the autothrottle system had increased the RPM of the engines because

the copilot increased the pitch angle (Attachment 1 (18), refer to § 2.3.3 above). One reason for closing the throttles could be that the increased RPM would accelerate the airplane after which the touchdown spot would be further down the (short) contami-

nated runway, which the copilot did not want to occur.

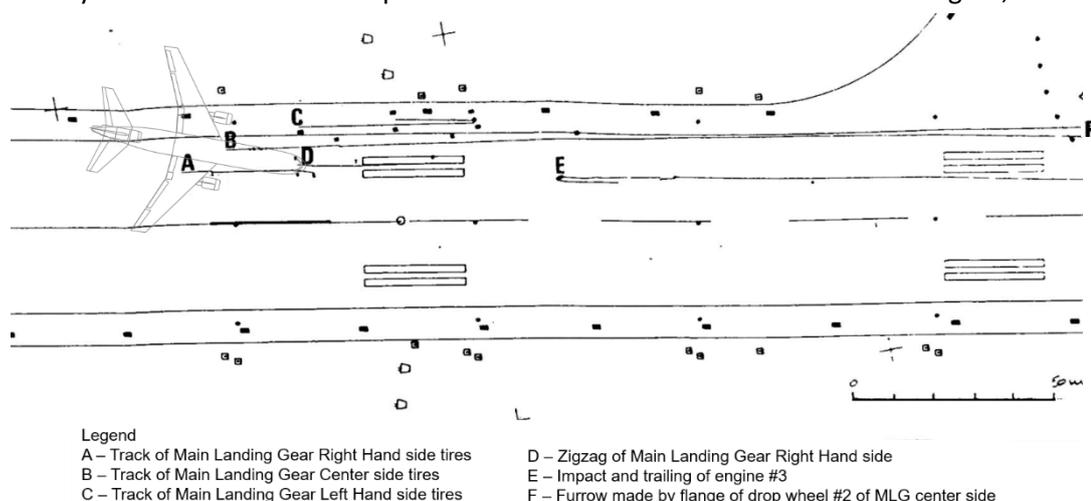
Figure 8. Impact area MP495 on runway 11, RoA Annex 11.

- 5.13.6. The airplane landed at the point as shown in Figure 8 below, half outside of the runway, with an 11° crab angle to the right, but in the direction of the runway as shown by the scratches A – E. Despite the near maximum rudder to the left during 7 s, and

until 7 s before touchdown, the runway heading was not reached because the airplane did not approach on the extended runway centerline, and the copilot reduced the rudder input to the center, even a little to the right and in the last 2 s of flight more than 50% to the left again, resulting in a rudder deflection of 10° to the left (Attachment 2 ⑦). Yawing from the approach heading 125° to runway heading 106° would have taken approximately 10 s, provided the rudder control power would be adequate (refer to § 5.11.4 above), and rudder pedal input would be sustained. The airplane then would have attained the runway heading just 2 s prior to touchdown, which is too late. Hence, the rudder input was too late for alignment with the runway, but had no sense either, because the airplane was not yet above the runway centerline. The control inputs, the point of touchdown and the direction of the traces on the runway prove that the airplane did not approach above the runway centerline.

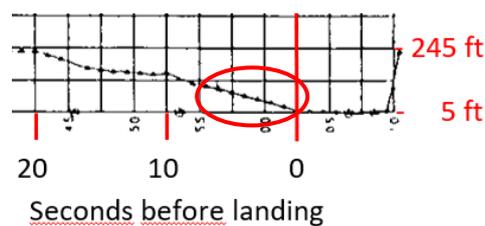
5.14.1. At 7 s before touchdown, the altitude was 93 ft as shown by the DFDR radio altitude

data in Attachment 2, of which a small section is shown in the adjacent figure. As the data shows, the final descent was a straight line; no sign of an increased rate of descent during the last seconds of flight. The final rate of descent was a constant $93/7 * 60 = 797$ ft/min, which is higher than normal, but

within the limits of the landing gear, which were presented by manufacturer McDonnell Douglas in an NTSB report of a similar accident (DCA97MA055). The landing gear survives a rate of descent of 1014 ft/min at maximum landing weight; no damage will occur to the fuel cells in the wings above the landing gear at normal touchdown accelerations up to 2 g.

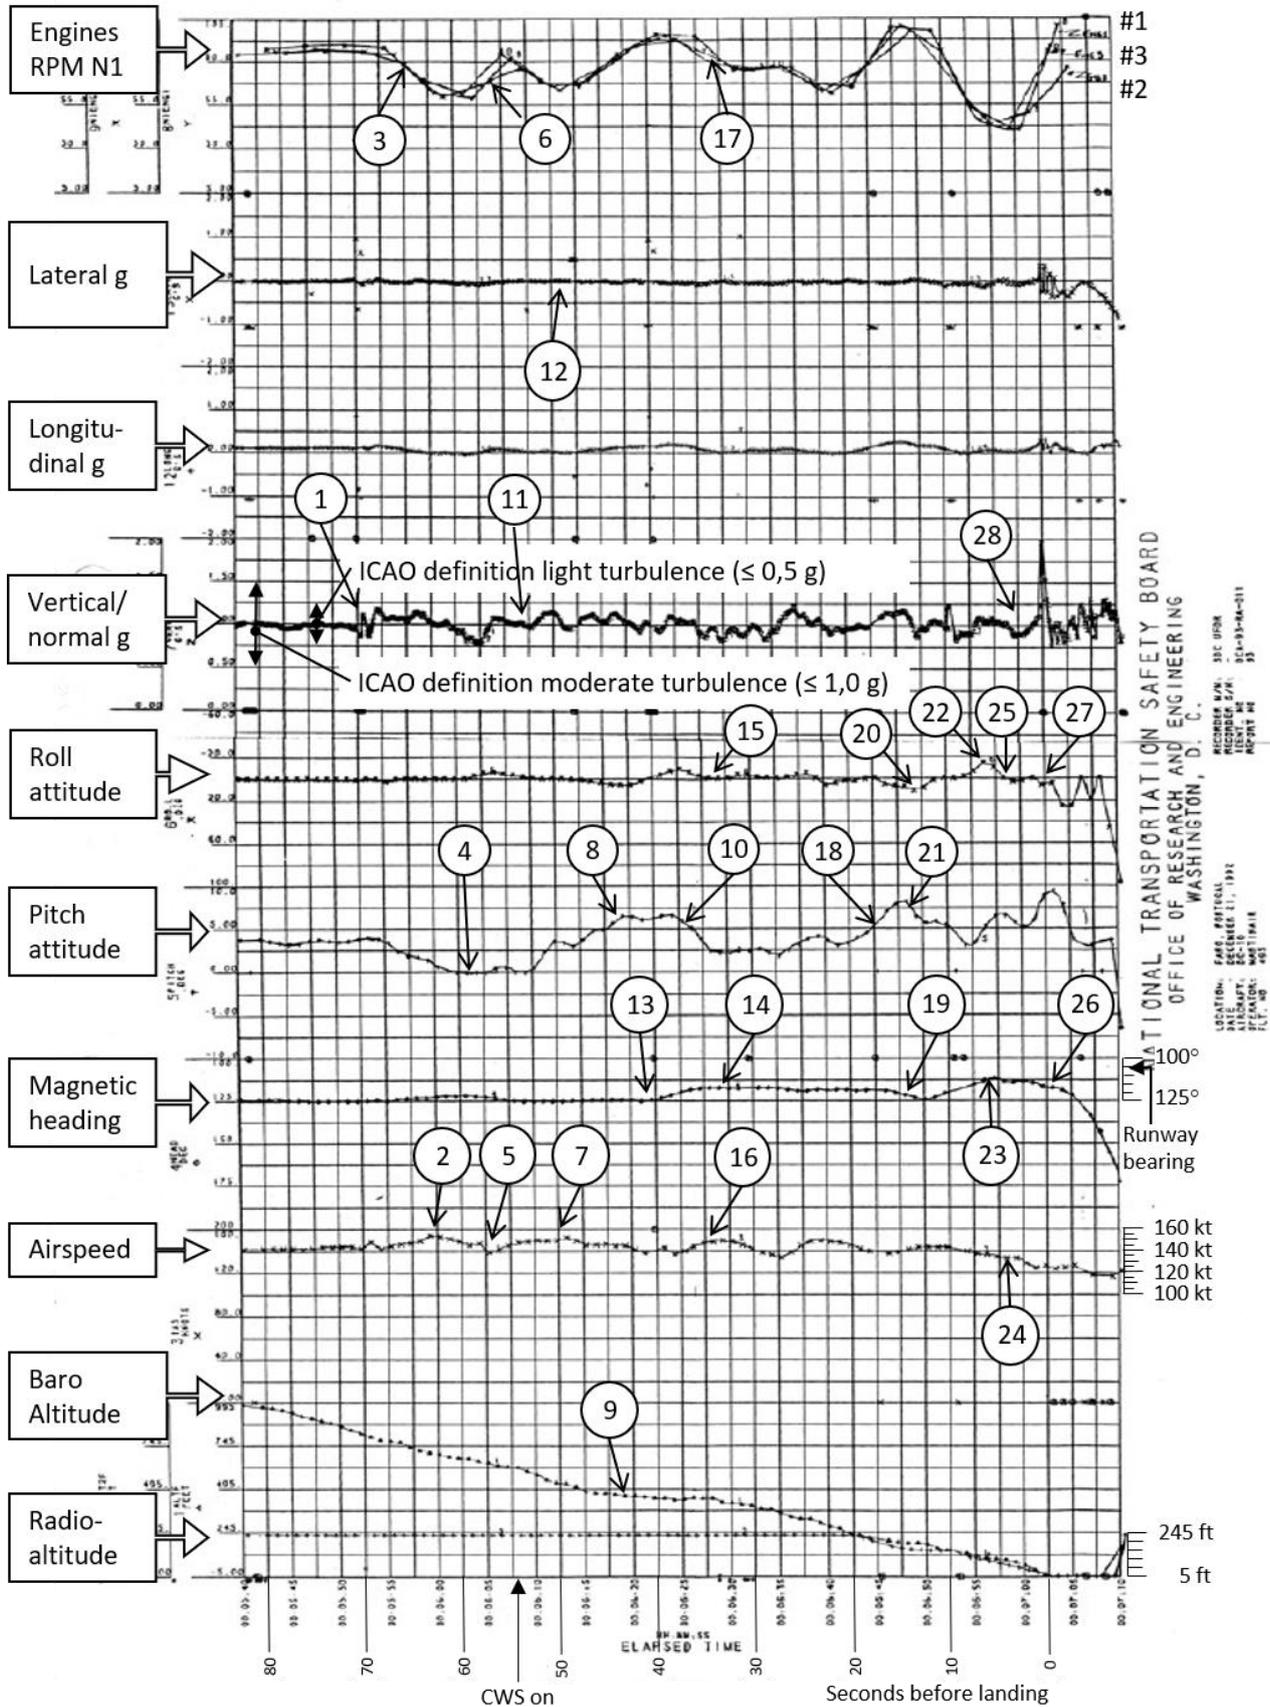
Attachment 1. Page 1 out of RoA, Annex 15. Part of DFDR Factual Report NTSB

- 5.6.3. DFDR magnetic heading data in Attachment 1 show that the heading of the airplane did not change during the last 80 s of flight, with exception of the periods during which the copilot pushed the left rudder pedal causing the airplane to yaw and hence, slip. The course over the ground does not change when yawing while keeping the wings level. The constant heading also proves that the crosswind component during the whole approach was nearly constant.

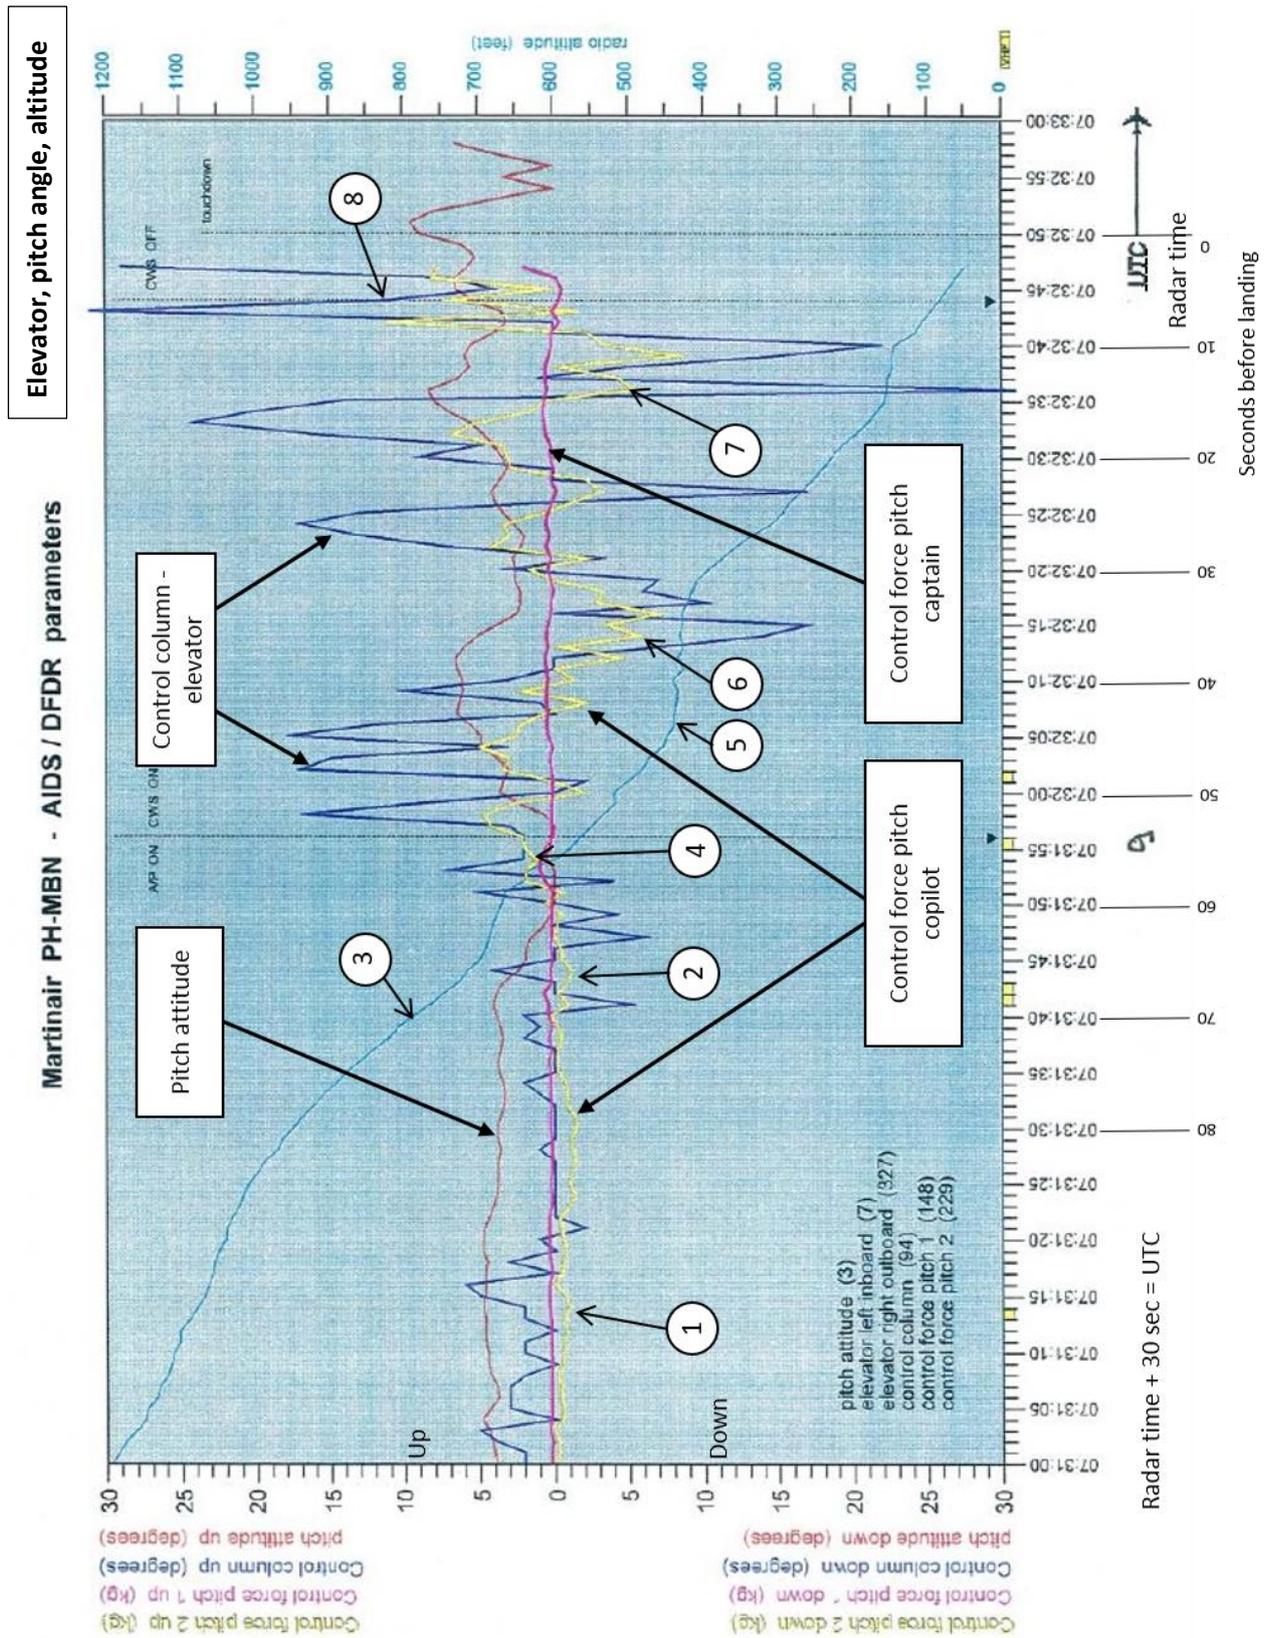
Attachment 4. Graph 9 out of RoA, Annex 9, AIDS data. Elevator, pitch angle, altitude

5.2.2. The AIDS control column pitch force graph in Attachment 4 (1) also shows that the copilot at that time pushed the elevator control up to 1,5 kg¹, in fact against the autopilot that was engaged to control the descent. A little pressure is normal, because the hands are loosely resting on the controls, also when the autopilot is engaged (during the approach); the control wheel and column move with the control surfaces as tactile feedback of the autopilot to the (human) pilot-flying (§ 2.6.1).

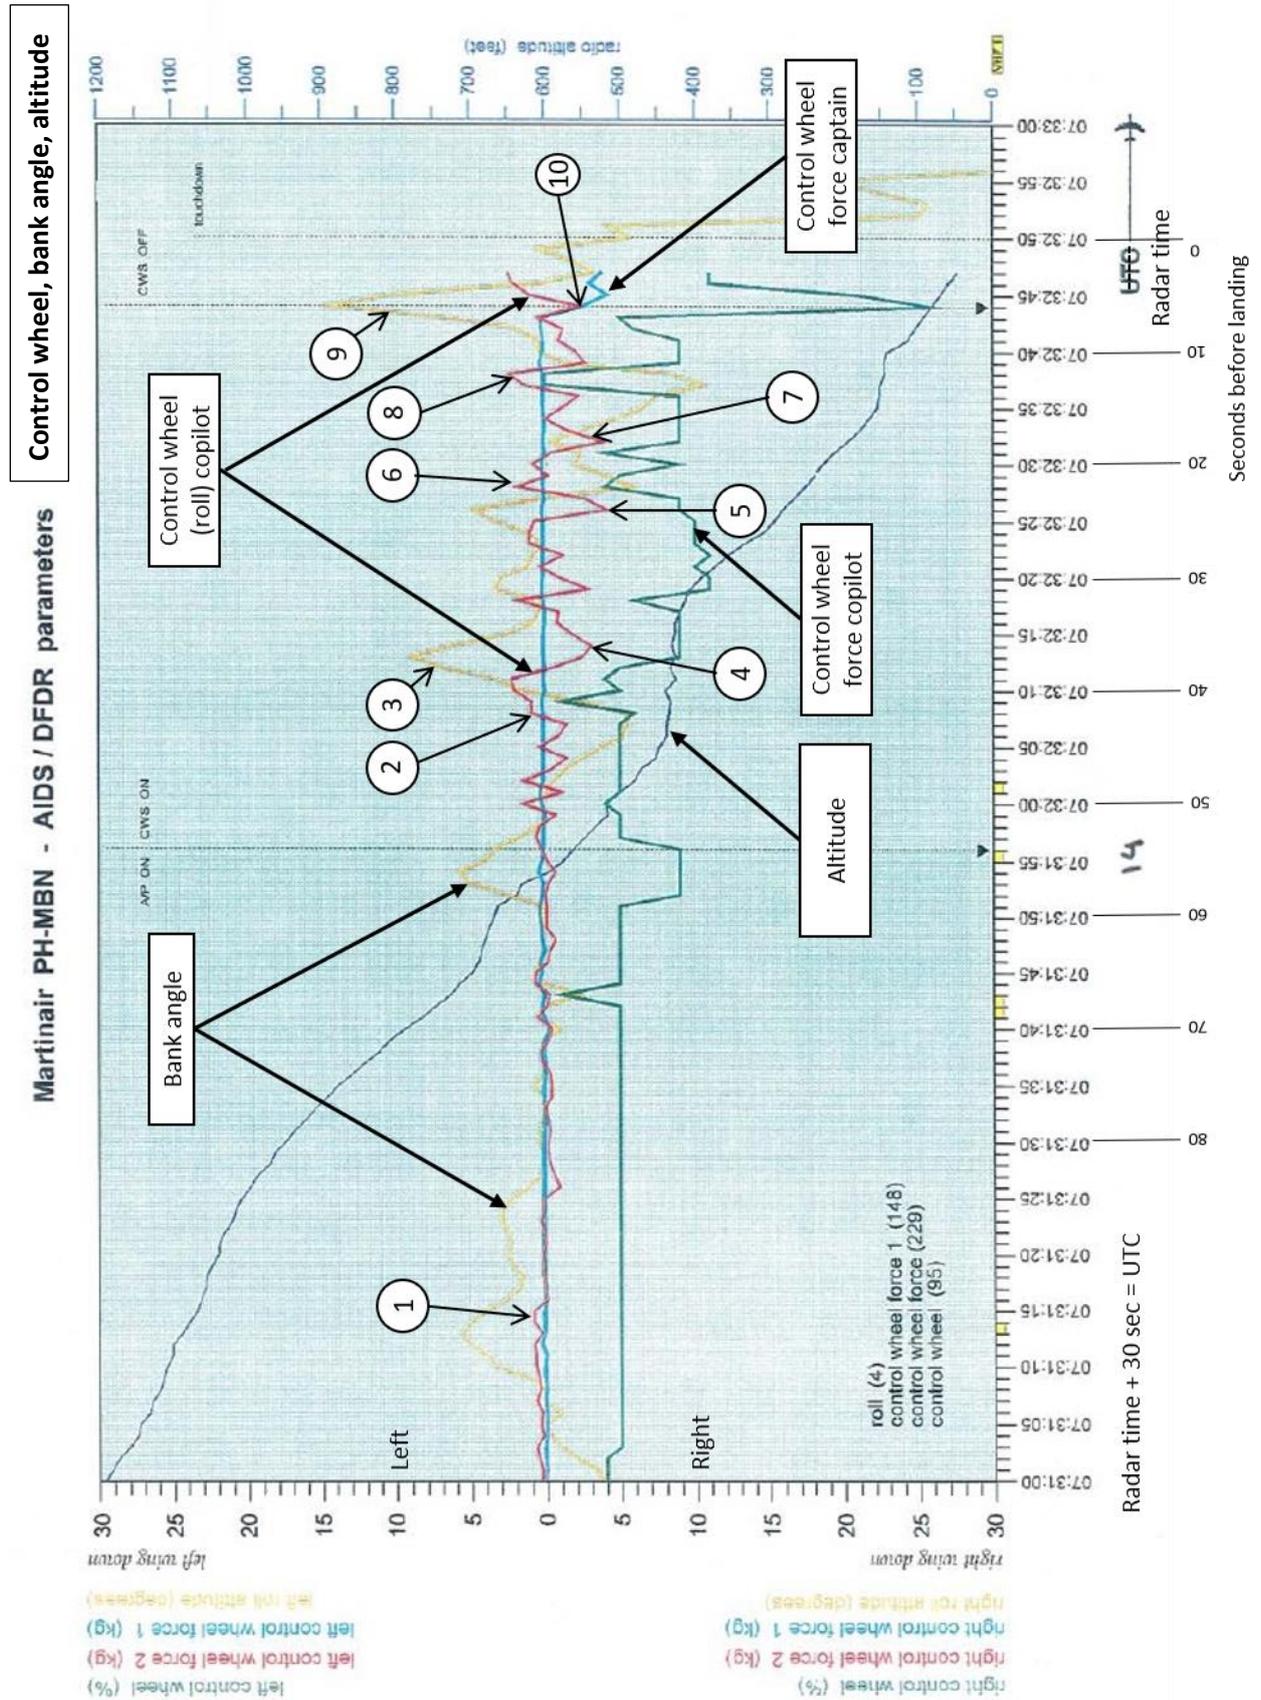
Attachment 5. Graph 14 out of RoA, Annex 9, AIDS data. Control wheel, bank angle, altitude

5.12.2. When the bank angle was increasing to 14° at 7 s (Attachment 5 ⑨), the captain grabbed the controls and both he and the copilot applied aileron control force to the right (Attachments 2 ③ and 5 ⑨). The captain did not call "my controls", hence the copilot did not release the control wheel. At 6 s, the copilot applied left aileron control force again, but the captain increased it to the right. These conflicting control inputs caused the CWS mode to disengage automatically (Attachment 5 ⑩).
