18 September 2007
Changed Dec. 2015

ANALYSIS

of the controllability of the crashed Saab SF-340B
at Schiphol Airport, 4 April 1994, during the final flight phase

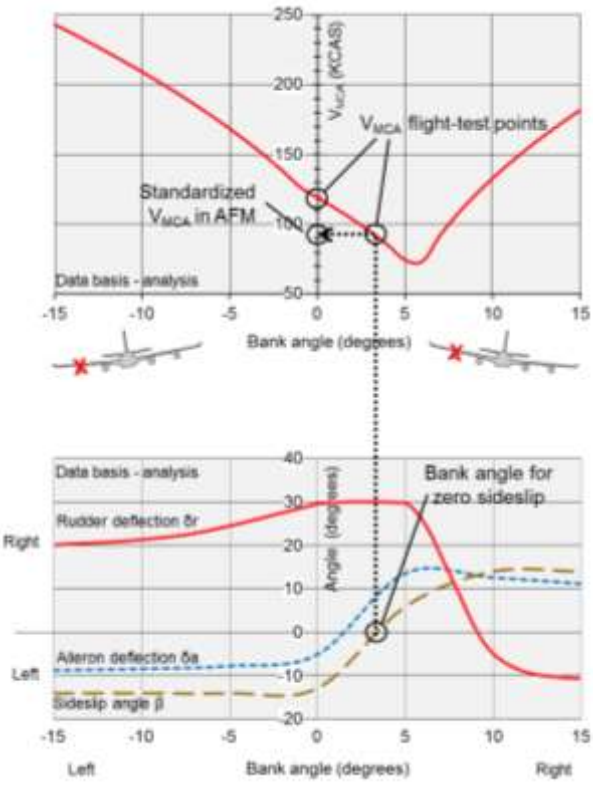
Effect of Bank Angle on V_{MCA} as calculated in Ref. D

Engine emergency procedures in AFM's or Operating Manuals of most multi-engine airplanes allow pilots to keep the wings level to within ±5 degrees after engine failure, but this is a dangerous misinterpretation of the applicable FAR and CS paragraphs that are for the certification of airplanes, nor for their operational use. In AFM's, a specific bank angle should be prescribed with V_{MCA} for which the listed V_{MCA} is valid. This small bank angle is most often between 3 and 5 degrees away from the inoperative engine. V_{MCA} increases also as the bank angle increases above 6 degrees into the good engine, in this example, because of the increase of sideslip and hence, the risk of fin stall.

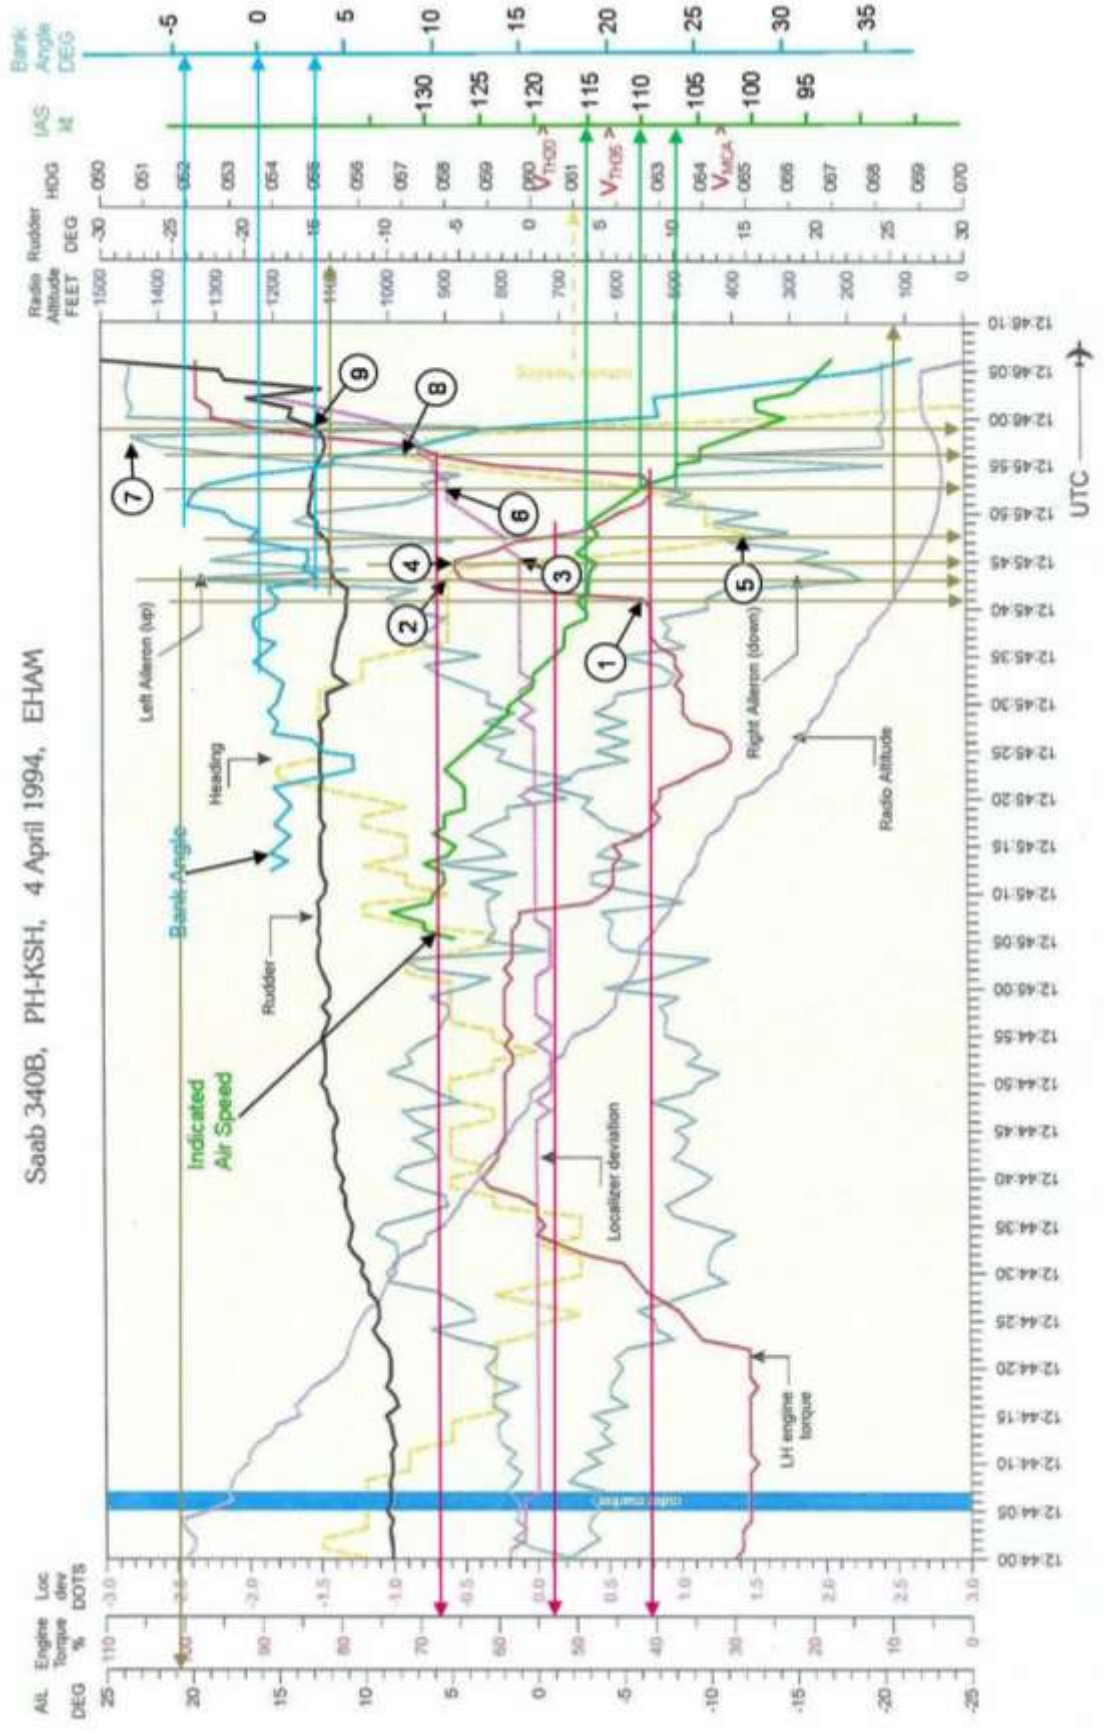
Attachment 1: Combined graph with all required data from the Aircraft Accident Report.

ther than attaining a safe bank angle away from the inoperative engine, a bank angle of 3 degrees was maintained to the wrong side, into the dead engine, for a few seconds, which definitely adversely affected (i.e. increased) the *actual* V_{MCA}.
At this time, the airplane was still controllable about the roll axis, though, as shown by the aileron deflection and bank angle plots.

4.6. Then, at 12:45:45 (④), the pilot slowly reduced the torque of the left engine to 40% (in 6 seconds). The propulsive lift of the left wing decreased instantaneously, causing the bank angle to return towards wings level with the current aileron deflection. Then the aileron deflection to the left was reduced, but then again increased to the left, most probably because the pilot wanted to return to the runway centerline.
As the torque decreased below 53% (12:45:48, ⑤) and the airspeed was 115 KIAS, the heading change reversed, indicating that the yawing moment generated by the still small rudder deflection could overcome the yawing moment due to the asymmetrical thrust and the drag of the right propeller. Since directional (yaw) control was regained at this time, the *actual* V_{MCA} had obviously decreased below the IAS. This decrease was caused by both the bank angle change (from 3 degrees into the wrong side to wings level) and the thrust reduction (⑤).

4.8. After the engine torque increased above 67% (⑧), the half rudder deflection to the left could not prevent the yawing motion from reversing to the right. The yaw rate increased to approximately 4 degrees per second to the right, also for the remainder of the flight. Directional control was now also lost (⑧). At event ⑨, about 7 seconds prior to the impact with the ground, the rudder deflection was finally increased, with some hesitation, to be fully deflected to the left at the moment of impact. The two-second discontinuity in the bank angle and airspeed data as shown in the graph may have been caused by the increased rudder deflection or the aileron pulse to the right (⑦). In any case, the full rudder deflection came way too late.

Bank angle and airspeed data were copied from the plot in Attachment 2 for easier analysis.

Refer to § 4 for explanatory text

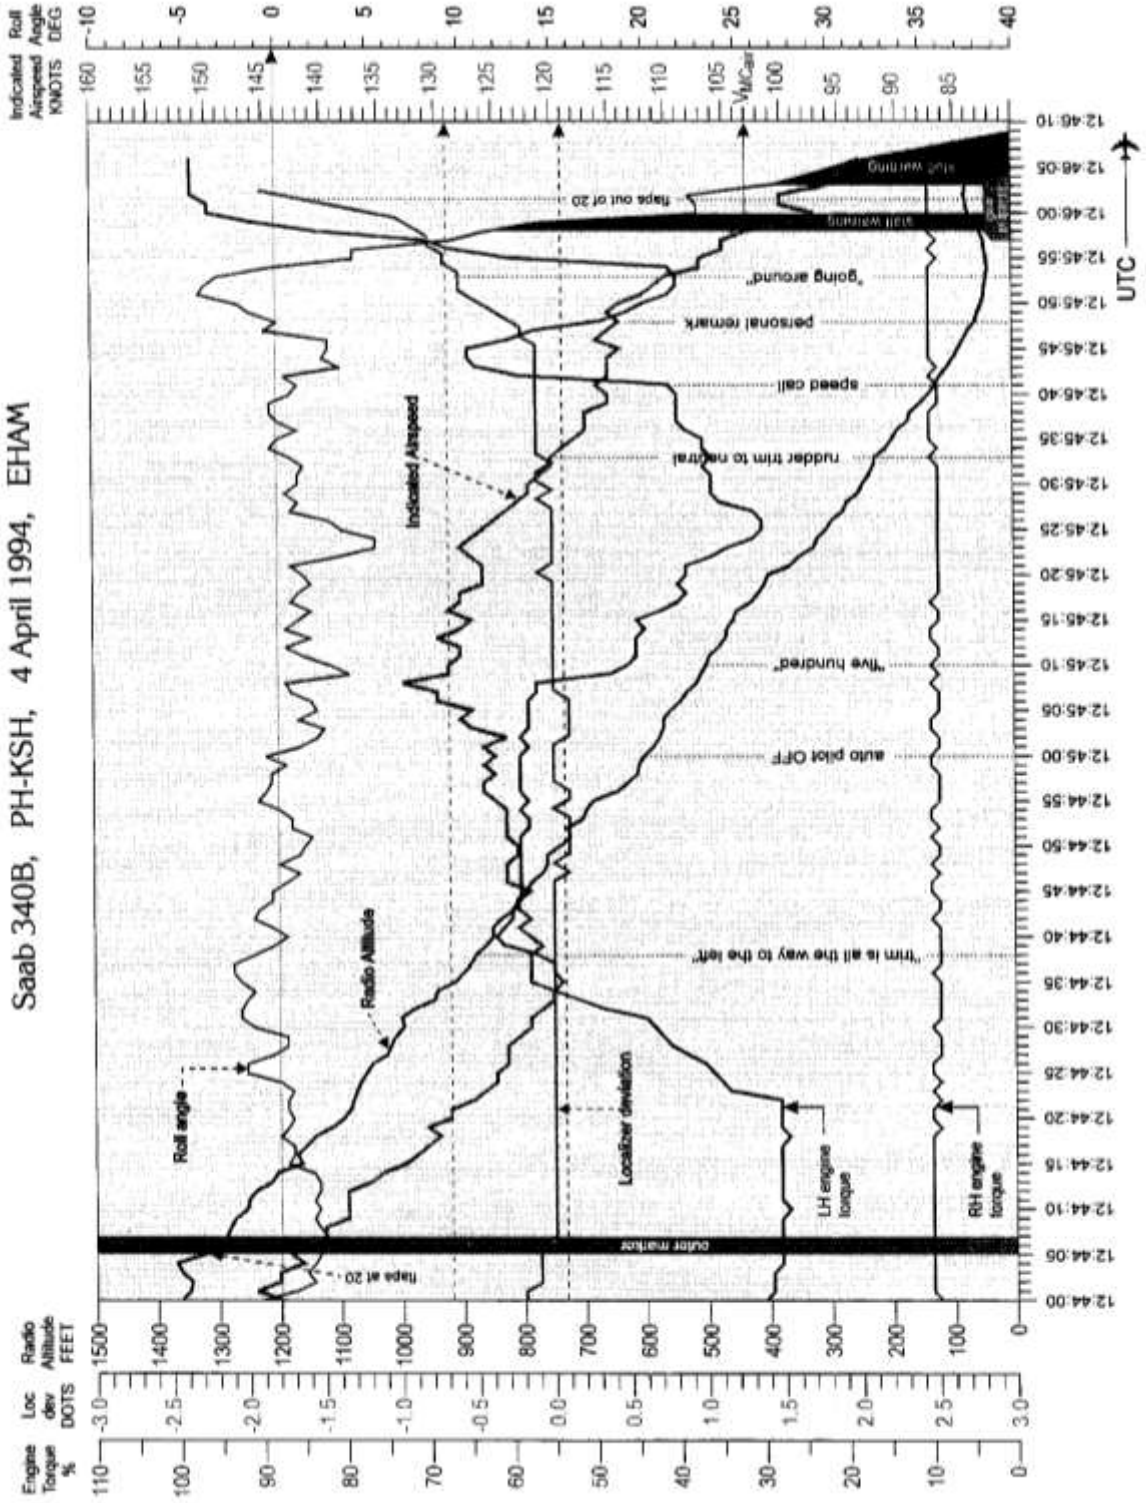
Attachment 2: Graph with bank angle and airspeed out of the Aircraft Accident Report.

The bank angle (roll angle) and airspeed data from this plot were copied into the plot in Attachment 1 on the previous page to allow for easier analysis. This plot is included for reference purposes only.
