Controllability of a Boeing 747-258F After Separation of Two Engines

4 October 1992, Amsterdam

Including The Theory of Engine-Out Flight

Harry Horlings
Graduate FTE USAF Test Pilot School

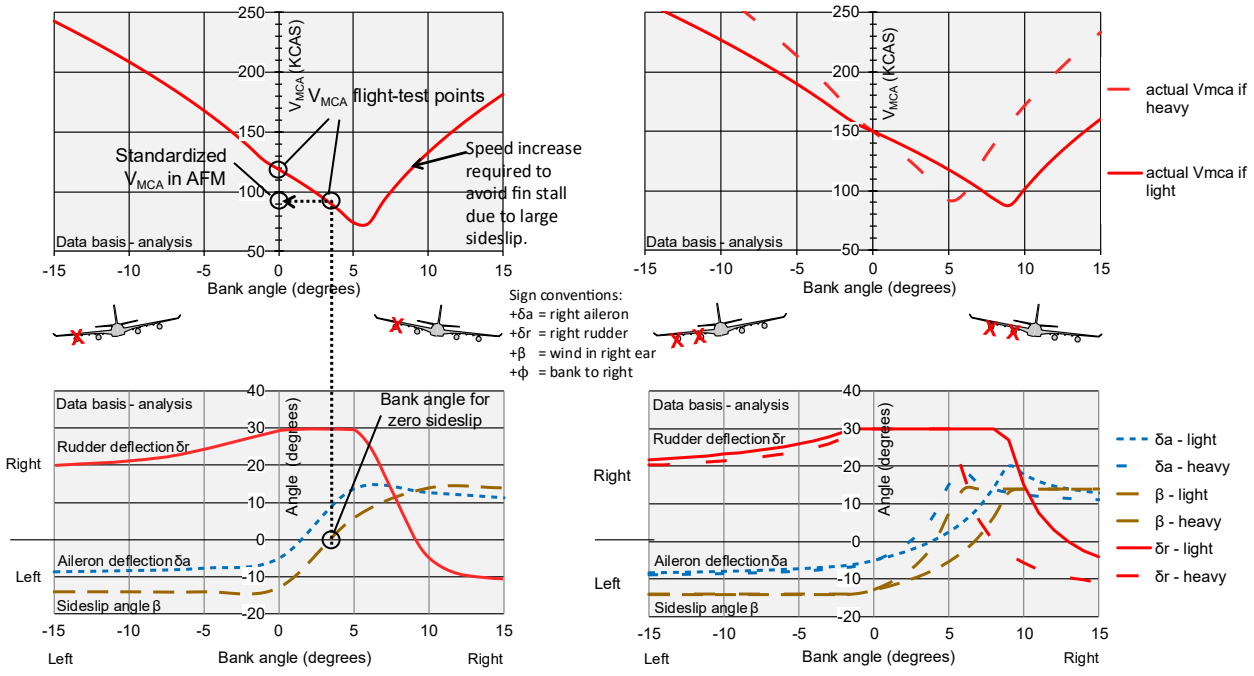
Figure 6. Effect of bank angle on V_{MCA} (top), and on the required control angle deflections and resulting sideslip (bottom) for OEI and TEI on left wing, other engines max. thrust.

3.3.3. ***The Effect of Bank Angle On V_{MCA}.*** The calculated graphs in the top of Figure 6 show the resulting minimum required airspeeds of a sample 4-engine airplane (like a Boeing 707) when OEI (the left engine #1) and when TEI (#1 and #2), and when maximum thrust is set on the engine(s) opposite of the inoperative engine(s). The graph on the right side also shows data for both high and low gross weights. The figures could not be recalculated for a Boeing 747-200, because its lateral-directional stability derivatives were not available. The airspeeds (q for dynamic pressure in Figure 5) shown in the top left and right graphs of Figure 6 are the ***actual* V_{MCA}'s** of the airplane for bank angles (ϕ) between −15° and +15° for the lowest gross weight (W, is mg in the side force equation in Figure 5).

3.3.4. ***Banking Into the Good Engine(s)***. The top left graph of Figure 6 shows the two V_{MCA} flight-test data points. For this airplane, which is in the test configuration as required by the FAA and EASA Flight Test Guides (lowest weight, aft cg, etc.), the sideslip angle β is zero when the bank angle is 3° away from the failed engine. At this bank angle, the drag is minimal, hence the remaining climb performance maximum. Therefore, the corresponding *actual* V_{MCA} (93 kt) will be published as the *standardized* V_{MCA} in the AFM (after extrapolating from the safe test altitude to sea level). The *actual* V_{MCA}, being the V_{MCA} that a pilot will experience in-flight, at bank angles other than the bank angle used for sizing the vertical tail and for measuring the standardized V_{MCA} during flight-testing (in this case +3°), is calculated with up to the maximum control surface deflections of either rudder (± 30°), aileron (± 20°) and for a sideslip angle less than or equal to ± 14°, being the horizontal angle of attack at which the fin with maximum rudder deflection (at maximum camber) stalls. The resulting speeds for bank angles in the calculated range of −15° to +15° are the lowest speeds at which an equilibrium of forces and moments can just be achieved and maintained, and hence, the loss of control can just be prevented when the asymmetrical thrust is maximum. The possible additional effects of a rudder ratio system, which reduces the rudder surface deflection with pedal input at higher airspeeds, are not included.

The bottom left side of Figure 6 also shows that at bank angles larger than the favorable bank angle of 3° away from the failed engine, for this sample airplane, the increasing side force W·sin ϕ causes the sideslip angle to increase to 14°, being the maximum allowable (horizontal) angle of attack of the fin with deflected rudder before it stalls.

In addition, at ≈ 9° of bank into the good engines the rudder deflection needs to be zero for balancing the forces and moments; the sideslip side force alone, caused by side force W·sin ϕ, takes care of counteracting the asymmetrical thrust yawing moment (weathercock). Some test pilots will also determine this bank angle for zero rudder. At larger bank angles into the good engines, such as shown in Figure 7, the increasing sideslip side force due to the increased sideforce W·sin ϕ needs to be counteracted by an opposite side force: the rudder deflection needs to be reversed to avoid excessive yawing into the good engine(s). As the V-shaped lines in the top graphs of Figure 6 show, the *actual* V_{MCA}, being the airspeed required to keep the control deflections required for maintaining the equilibrium of forces and moments within their mechanical limits and the sideslip smaller than 14°, increases when the bank angle increases.

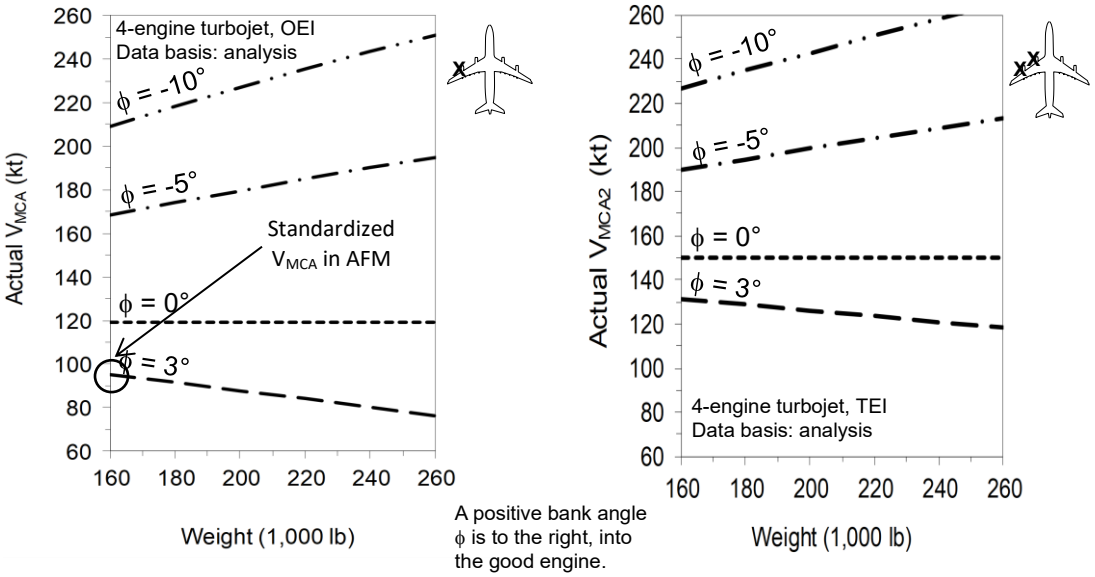
Figure 8. Effect of weight W on V_{MCA} of a sample 4-engine airplane for #1 (and #2) inoperative for several bank angles ϕ. Other engines max. thrust.

3.3.8. ***The Effect of Weight On V_{MCA}***. The graphs in Figure 8 show the effect of weight for several bank angles of the same sample airplane. The airspeeds at the intersection of the bank angles with the ordinate, the vertical *actual* V_{MCA} axis, are the same as in Figure 6 above. Figure 8 is similar to the figure that Lockheed presents in the C-130 Performance Manual SMP777, and will also be similar to Boeing 747 data, as for any multi-engine airplane when an engine is inoperative, and the thrust of the opposite engine is maximum; only the numbers will be different.

When the wings are level (bank angle ϕ = 0°), weight has no effect on the side forces, because sin ϕ in side force W·sin ϕ is zero. The asymmetrical thrust can only be counteracted by a side force due to rudder deflection, which results in a near −14° sideslip (wind in the left ear), which also causes much drag (see Figure 6 and Figure 3 above).

When banking into the inoperative engine (negative ϕ in this example in Figure 8), the *actual* V_{MCA} increases with weight. At the maximum weight of 260,000 lb, the *actual* V_{MCA} is ≈ 250 kt, 155 kt higher (!) than the standardized AFM-published V_{MCA} (see also Figure 6).

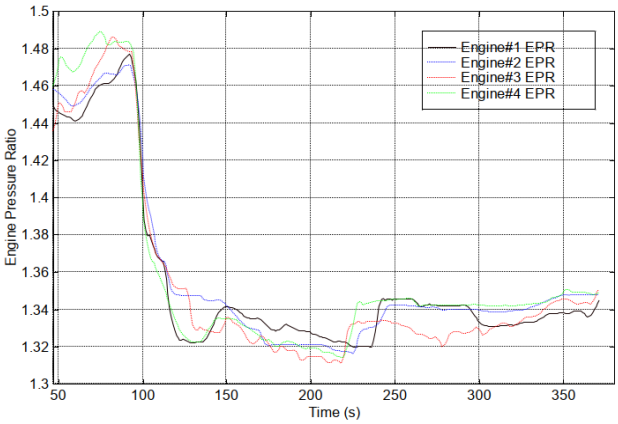
Figure 9. FDR Engine Pressure Ratio (EPR) data (NLR, ref. 2, Fig. 34.)

5.2.4. During takeoff, the initial thrust setting (Engine Pressure Ratio – EPR) was between 1.44 and 1.46 (Figure 9 below), which is lower than the maximum approved 1.72. Engine thrust during takeoff may be larger than Maximum Continuous Thrust (MCT - EPR 1.32) for an approved period, usually during a few minutes. Thereafter, the engine thrust must be reduced to MCT. This is what the Boeing 747 pilot factually did (Figure 9).

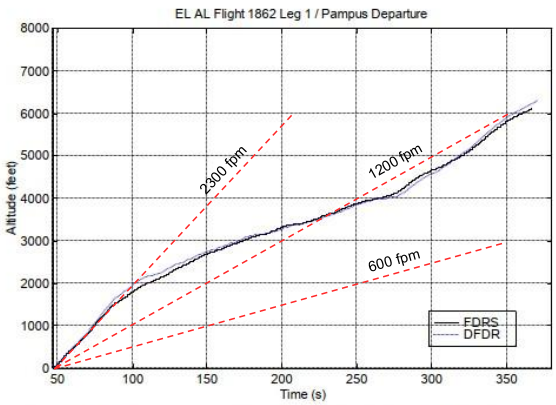
Figure 10. FDR altitude data and climb performance (NLR, ref. 2, Fig. 23).

5.2.5. The FDR-recorded altitude is presented in Figure 10, including a few lines showing the ROC in feet per minute (fpm). As shown, the ROC after liftoff from the runway was initially 2300 fpm, and from 100 seconds an average of 800 fpm until ≈ 225 seconds after liftoff.

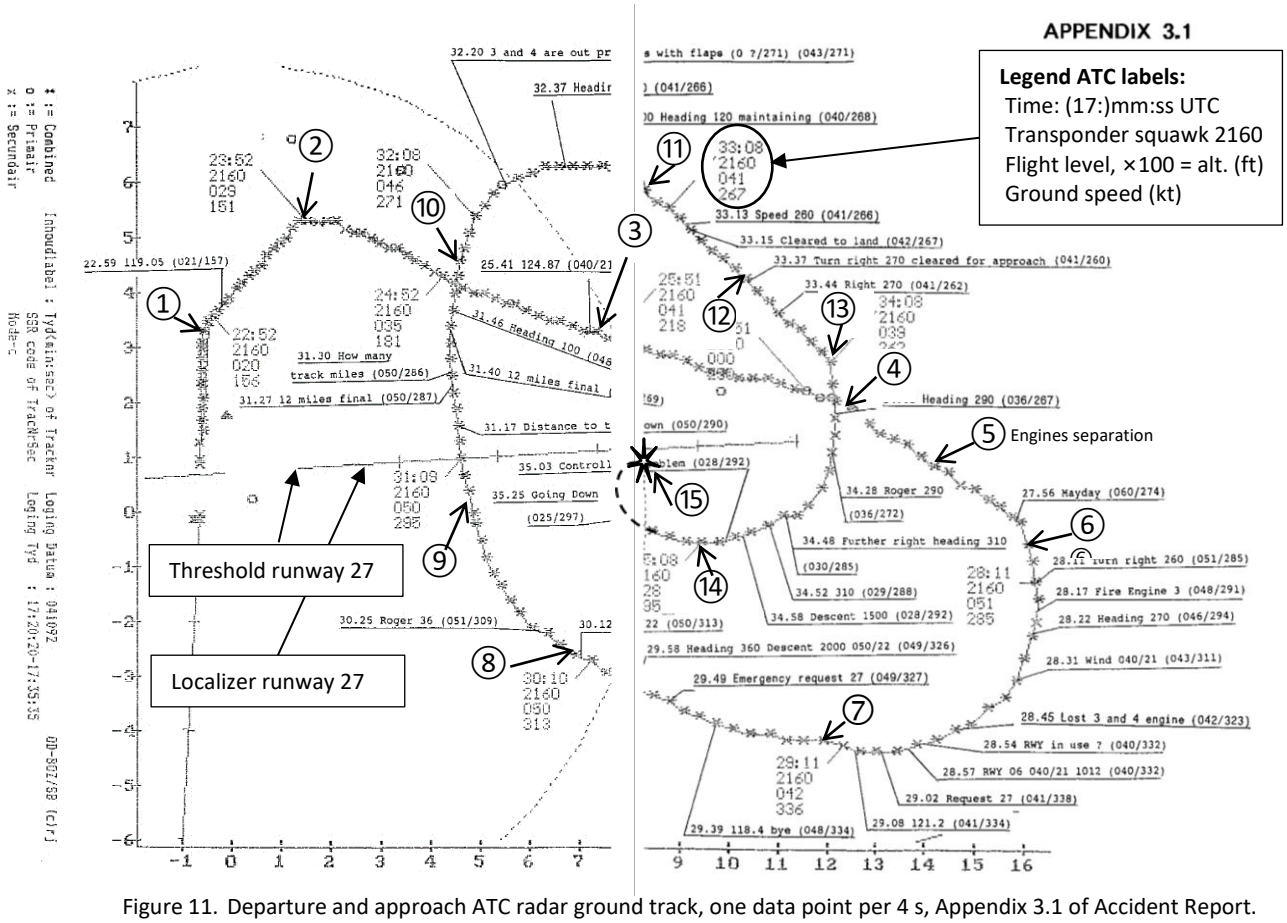
Figure 11. Departure and approach ATC radar ground track, one data point per 4 s, Appendix 3.1 of Accident Report.

5.3.1. The flight path, i.e. the plot of the ground radar track of the airplane from takeoff to the crash was included in the accident report (ref. 1, Appendix 3.1) and is copied in Figure 11 below. The circled numbers refer to events in the FDR bank angle data of the flight in Figure 15 below, that show the turns before and after the engine separation, and are used in the analysis from § 5.5 below as well. The plot was however not the original plot.

5.3.2. A board member testified[9] that changes were made in the first part of the route, and the lead investigator testified[10] that the track was calculated by using both the FDR heading data and the wind. However, the FDR-recorded heading of an airplane of which two engines are inoperative cannot be used to calculate the true course of the airplane, because this heading includes a large sideslip angle, unless straight flight is being maintained while also maintaining a small bank angle between 0 and 5° into the good engines, when sideslip is zero (Figure 6, bottom right). The angle of sideslip is not measured in an airliner and hence, is not recorded on the FDR, but can be up to 14°, as shown in Figure 6 above for bank angles between −15° and +15°. Hence, the FDR-recorded heading cannot be used with the drift angle due to the wind to calculate the ground course/track. As was mentioned a few times before, a flight is not coordinated, when the thrust is asymmetrical. The lead investigator was obviously unaware of the difference between sideslip and drift angles. The exact ground track is not of importance for the analysis below, which is aimed at the controllability after engine failure; therefore, it is assumed that this figure presents the correct ground track, just for reference purposes.

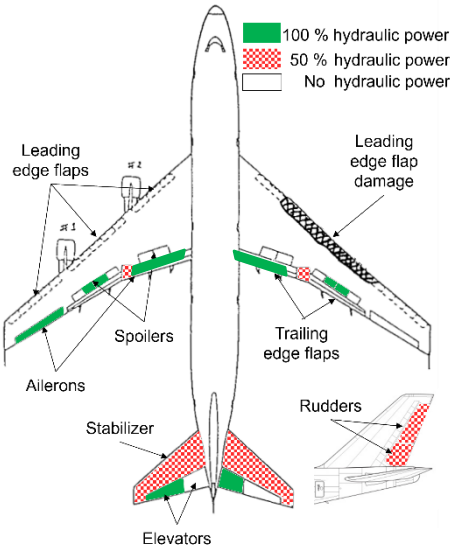
Figure 12. Remaining aerodynamic control surfaces after separation #3 and #4.

5.4.2. ***Remaining Control Surfaces***. After the loss of engines 3 and 4, the remaining hydraulically actuated aerodynamic control surfaces by hydraulic pumps on engines 1 and/or 2 were: left outboard aileron, left outboard elevator, right inboard elevator, spoilers 2, 3, 10, 11, and the inboard trailing edge flaps (ref. 1, page 15), as shown in the adjacent Figure 12. Actuated with 50% hydraulic power, from only engines 1 and/or 2 were: left and right inboard ailerons, upper and lower rudders, and stabilizer trim.

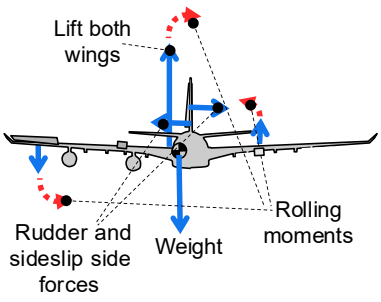
Figure 14. Shift cg and lift vector both wings, reduced roll control.

5.4.11. ***Wing Lift Imbalance After the Separation of Two Engines.*** When a wing is damaged and its generated aerodynamic lift decreases, the vector representing the sum of the lift vectors of both individual wings together, which normally acts in the aerodynamic center on the centerline, would then displace laterally too, and generate a rolling moment. If the displacement is large, outside of the displaced cg, the displaced combined lift vector of both wings generates a rolling moment to the right, as is shown in adjacent Figure 14. The rolling moments generated by the rudder and sideslip side forces, which act above the cg, are not shown here; forces are not to scale.

FDR data (Figure 15 below) shows, that the pilots obviously needed a rolling moment to the left; the aileron control wheel was rotated to the left for the remainder of the flight. This in fact means that the aerodynamic lift vector of both wings must have shifted into the good engines' side, even outboard of the also displaced cg due to the loss of the weight of two engines, causing a rolling moment to the right that needed to be counteracted by control wheel to the left, as shown in Figure 14. This large lateral shift of the lift vector might have been caused by the large loss of lift of the right wing due to structural damage caused by the separation of both engines, as shown in Figure 12 above. The extent of the damage of the Leading-Edge flaps and of the wing section behind the damaged flaps could not be determined in detail (ref. 1), but must have been considerable given the large required aileron control input to the left after the separation of the engines and during the remainder of the flight; the loss of lift of the right wing might have been larger than the loss of weight of two engines with their pylons.

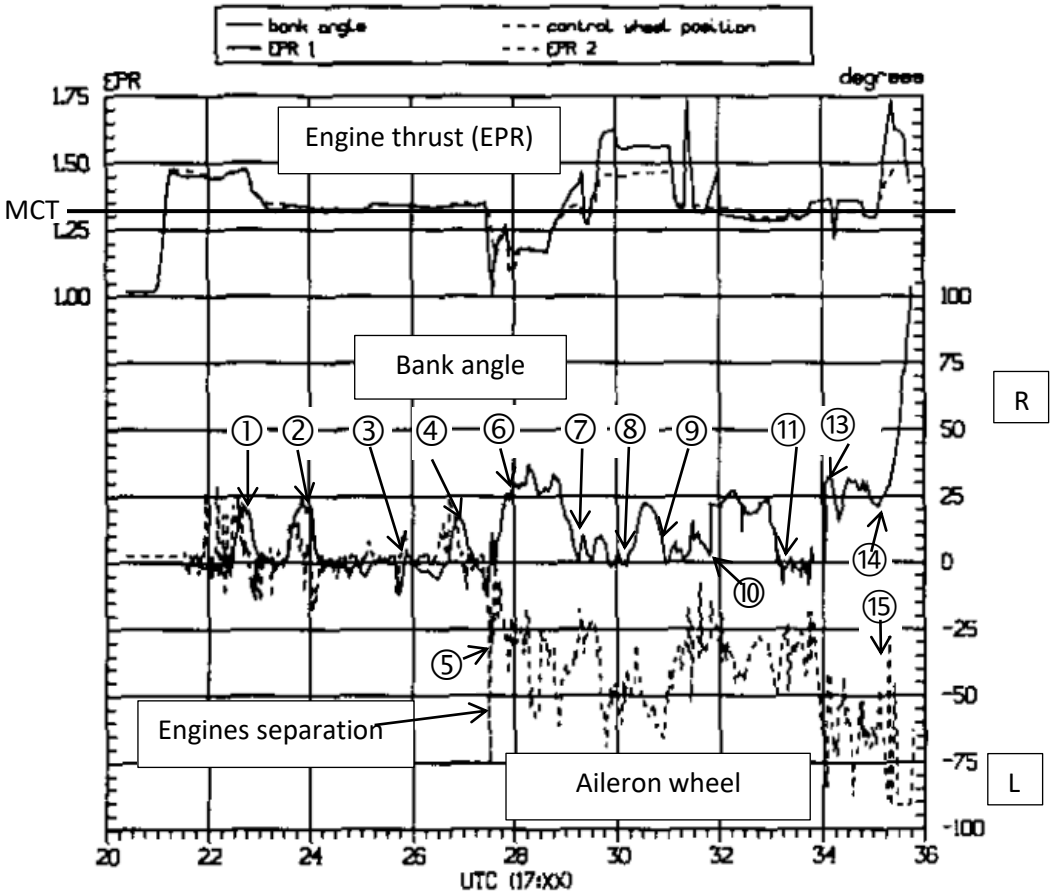
Figure 15. Bank angle, aileron wheel and EPR (FDR data, ref. 3). The circled numbers correspond with events in Figure 11.

5.4.14. An average of 35° of aileron control wheel input to the left was required during the remainder of the flight for maintaining lateral control at the average airspeed of 270 kt and an average EPR of 1.30. At this airspeed and this thrust setting, that was less than maximum EPR 1.72, the equilibrium of lateral forces and moments could obviously be maintained, because the airplane remained controllable.
But, as stated before, the equilibrium of forces and moments changes considerably with airspeed, asymmetrical thrust level, and bank angle.

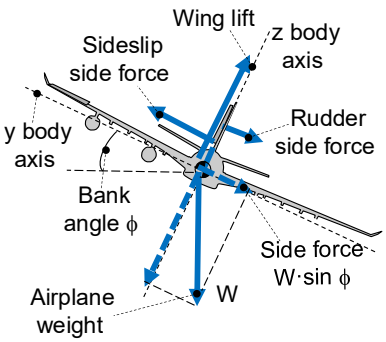
Figure 16. Side forces during banking 25° into the lost engines, damaged right wing. Forces not to scale.

5.4.18. ***Forces and Moments at a Larger Bank Angle***. During the final turn from event ⑬ in Figure 11 and in Figure 15, an average bank angle of 25° to the right was attained. As was discussed in § 3.1.8 above, when an airplane is banked, a component of the weight acts as side force W·sin ϕ in the center of gravity (in the body axes system) and hence, does not generate a yawing moment (moment arm = zero). The yawing moment to counteract the thrust yawing moment (about the z axis), still needs to be provided by the rudder though (Figure 16).

The rudder side force and side force W·sin ϕ increase the sideward acceleration, therewith increasing the sideslip, until the increasing opposite side force due to sideslip balances the sum of the rudder and the bank angle (W·sin ϕ) side forces. Such an equilibrium is possible if the airspeed is not too low for the fin with rudder to generate an adequate side force and a yawing moment to act against the thrust- and other yawing moments, and the ailerons generate an adequate rolling moment to maintain the bank angle, but the resulting sideslip is large, as shown in Figure 6 (bottom right – mirrored). This figure also shows that the rudder requirement at increasing bank angles into the inoperative engines is less than maximum because of the large sideslip. The airplane, after the separation of the engines, remained controllable during the 25° banked turns so far, i.e. while the thrust setting, i.e. the thrust yawing moment, was not maximum (Figure 15). The required aileron and rudder deflections to balance the forces and moments were quite large though (Figure 15 resp. Figure 18). The pitch attitude and the airspeed could be maintained using the elevator during the slow, controlled descent. However, the equilibrium of lateral forces and moments was about to change dramatically.

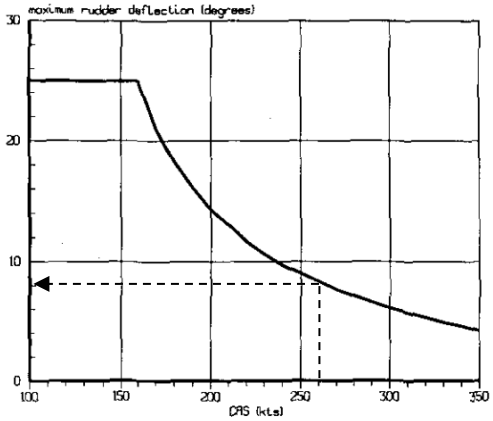
Figure 17. Rudder deflection as a function of airspeed with full rudder pedal.

5.4.20. ***Rudder Ratio Changers*** of the Boeing 747 reduce the deflection of the upper and lower rudders with increasing airspeed to keep the air loads on the fin with rudders within structural (design) limits. The (asymmetrical) engine thrust does not change with increasing airspeed, so the side force that the fin with rudder must be able to generate for counteracting an asymmetrical thrust condition, does not have to change with airspeed either. Since this force (horizontal lift) is proportional to the square of the airspeed (≡ V^2), the rudder deflection should decrease with airspeed as a quadratic function as well (≡ $1/V^2$). This is achieved by the rudder ratio changers, as shown in Figure 17. The maximum available rudder yawing moment, required to counteract the thrust yawing moment, remains approximately equal to the maximum asymmetrical engine thrust yawing moment at all airspeeds. A pilot might not notice differences in directional control when using the rudder pedals at low and high speeds, and will not have to worry about overloading the fin at high speeds, not even with full rudder pedal input, although the AFM might still warn to avoid abrupt inputs.

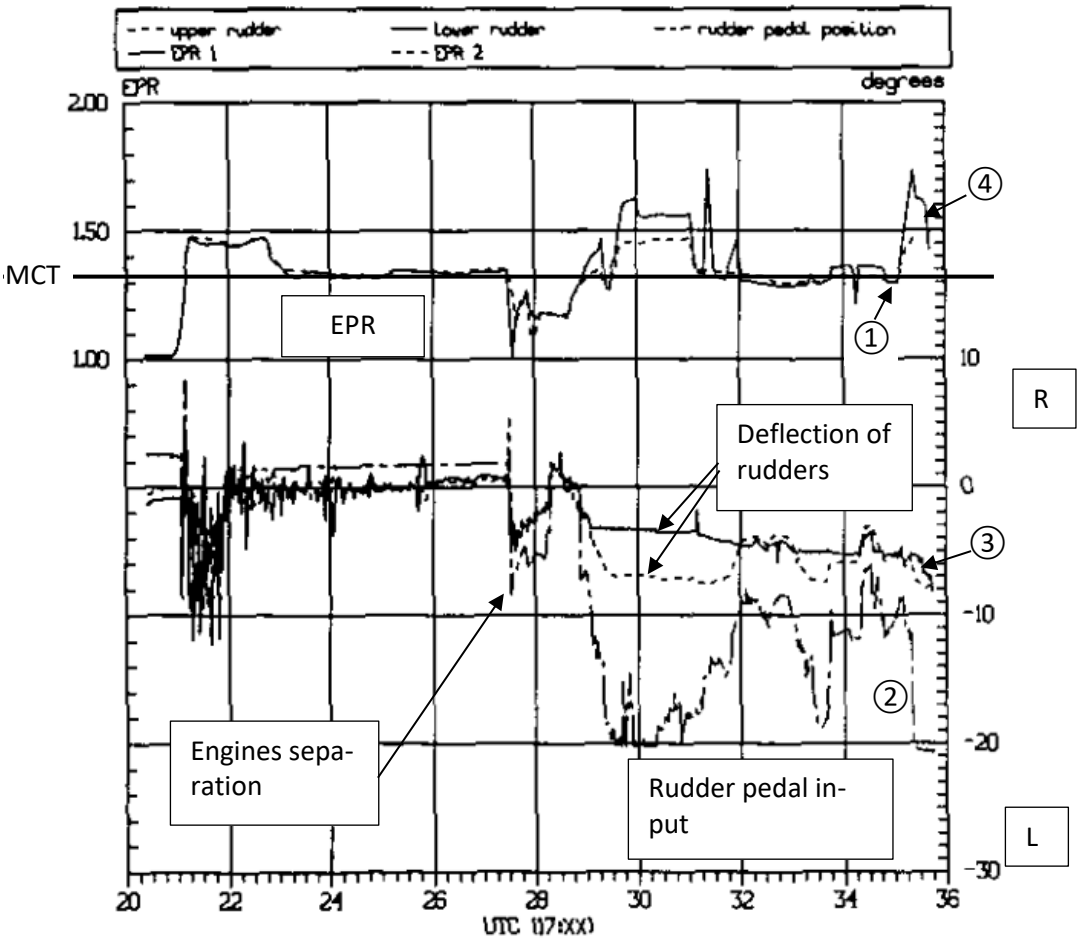
Figure 18. Rudder deflection, rudder pedal position and EPR (FDR data ref. 3).

Small differences might occur between the deflection of the upper and lower rudders because they are controlled by two separate ratio systems, which are cross-connected to the left and right upper and lower pitot tubes and static pressure sources. This effect can be seen in the FDR data in Figure 18 when the rudder pedal input increases and hence the

sideslip, which increases the static pressure on one side of the fuselage. Also obvious is the limitation of the rudder deflection by the rudder ratio changers to the maximum 8° (Figure 18 above) at larger pedal inputs at an airspeed of 260 kt.

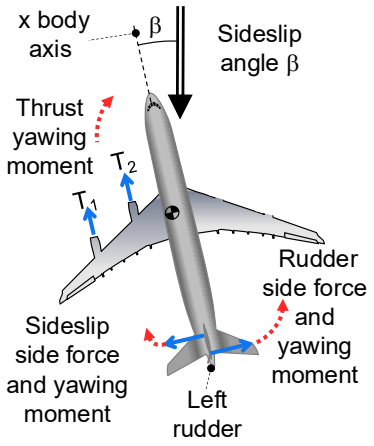
Figure 19. Most important directional forces and yawing moments during straight, engine-out flight, wings level.

5.4.21. ***Directional Controllability Flight 1862***. After the separation of the right-wing engines, the asymmetrical thrust yawing moment generated by the engines on the left wing yaws the airplane to the right about the cg. The sideslip angle increases instantaneously (wind from the left), as does the drag.
The pilot must counteract this yawing moment using the rudder, and the lateral side effects/moments using the ailerons to re-establish straight flight. The rudder side force not only generates a yawing moment to counteract the thrust yawing moment, but also accelerates the airplane sideways, reversing and increasing the sideslip angle, in this case to the right. The sideslip angle increases until the increasing opposite side force due to this sideslip, generated by the fin and airplane fuselage, equals the rudder side force. The side force due to sideslip however, also generates a sideslip yawing moment that enhances the thrust yawing moment (Figure 19). The rudder deflection needs to be increased to overcome this as well; the sideslip increases. Both the resulting sum of the side forces, generated by the vertical tail by rudder and sideslip, and the resulting sum of the yawing moments, generated by the thrust and the vertical tail by rudder and sideslip, must be zero to achieve an equilibrium of forces and moments, which is required to be able to maintain equilibrium flight. The large sideslip and the control deflections for bank angle zero are shown in Figure 6 bottom right.

At a high enough airspeed this equilibrium will not be a problem, but at too low a speed or at a high asymmetrical thrust setting, the fin- and rudder-generated forces and moments might not be adequate anymore to counteract the thrust yawing moments. The minimum speed required to maintain the equilibrium of directional forces and moments, in other words to maintain directional control, is highest when the level of asymmetrical thrust is maximum.
After the separation of the engines, the directional equilibrium of forces and moments could obviously be re-established and maintained at the current airspeed and the (less than maximum) asymmetrical thrust setting of engines 1 and 2; the airplane remained controllable, but a sideslip angle remained, as shown in Figure 19 and in Figure 6 for straight wings-level flight. Hence, the drag was not minimal, which in this case was not bad; the airplane had to descend for the return to the airport anyway.

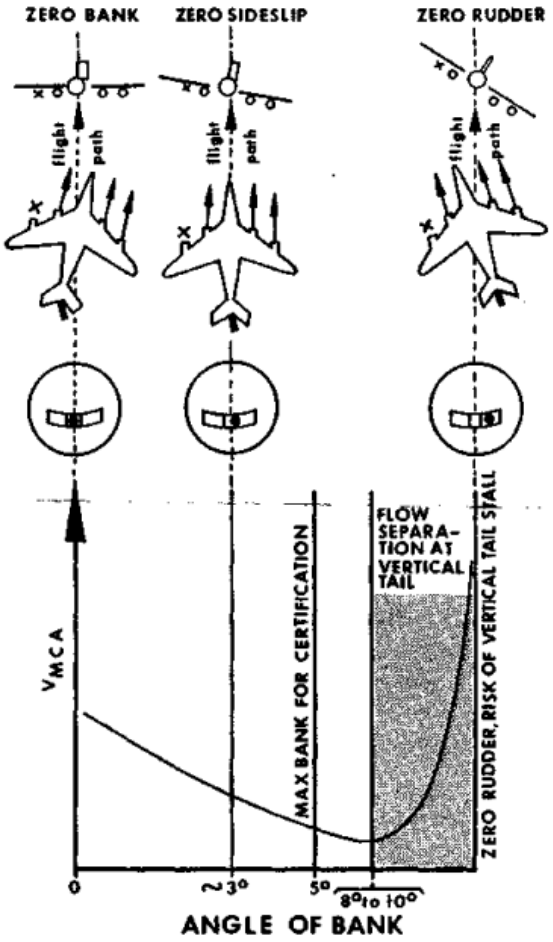
Figure 20. V_{MCA} versus Angle of Bank, Engine #1 inoperative, KLM DC-8-50 Flight Crew Reference Guide, 1988.

5.8.25. ***KLM Flight Crew Reference Guide***. The V_{MCA}'s of a DC-8-50, also a 4-engine turbofan airplane, were published in § 1.3.2 of the KLM Flight Crew Reference Guide (FCRG – ref. 22) of 1988, as shown in Table 1 above.
This table confirms that the effect of bank angle is indeed large for this swept-wing airplane; V_{MCA} with one engine inoperative when the wings are kept level is 32 kt higher than published V_{MCA} (which is determined with a 5° bank angle into the good engines for smallest sideslip, hence lowest drag, and max. climb performance). The published V_{MCA} when two engines are inoperative (V_{MCA2}), which is also determined with 5° of bank into the good engines, is 155 kt and increases to an *actual* value of 191 kt when the wings are kept level. The *actual* V_{MCA2} at other bank angles into or away from the inoperative engines will be much higher than 191 kt for a DC-8, as might have become clear in the analysis presented in § 3.3.3 above and shown in the adjacent Figure 20 for a turn into the good engines. This figure confirms what is shown in the calculated Figure 6 on page 19 above, for engine #1 inoperative.

This (quite good) KLM manual also states: *"Bank towards the operating engine (s) must not be exaggerated. On aircraft with wing-mounted engines V_{MCA} decreases 6 to 7 kt/degree of bank up to a bank angle of 5°. Above 5° bank the reduction in V_{MCA}/degree of bank is smaller and at 8-10° bank, V_{MCA} starts to increase rapidly due to the start of flow separation at the vertical tail caused stall and consequently loss of control. A bank towards the wrong side, i.e. towards the dead engine(s) will increase V_{MCA} by a similar and even higher rate; 5° bank towards the wrong side can increase V_{MCA} as much as 60 to 80 kt above the certified V_{MCA}*". This manual confirms the effect of bank angle on V_{MCA} presented in § 3.3 of this analysis. Regrettably, the accident investigators and board members (many of them were airline pilot) did obviously not know, understand, and review this manual.
