FINAL REPORT

requested by judgment of the 8th of July 2015
issued by the HAGUE DISTRICT COURT
(Chamber of Commercial Affairs)

Accident occurring in FARO Airport – Portugal
21st of December 1992

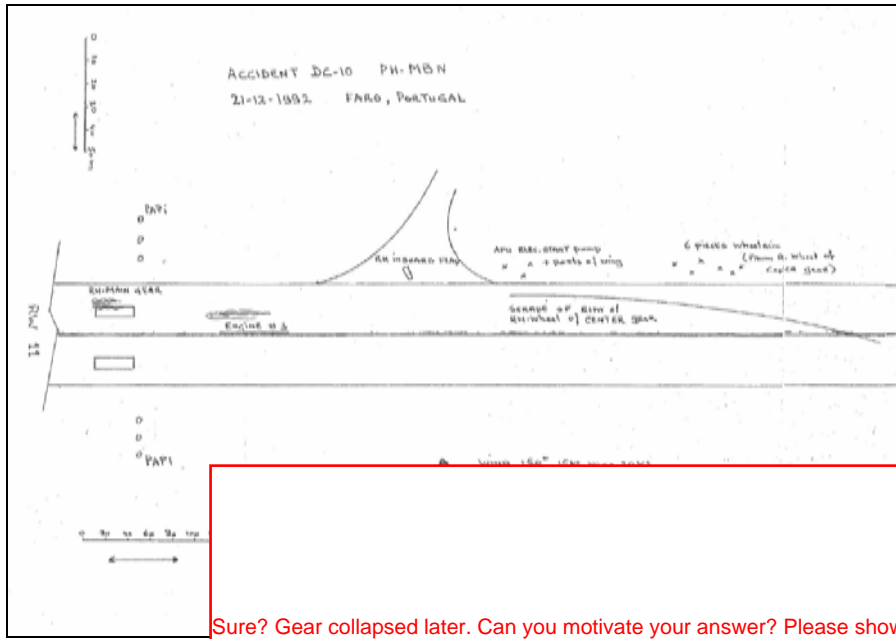
Why this figure, and not the off

Sure? Gear collapsed later. Can you motivate your answer? Please show calculations, etc.

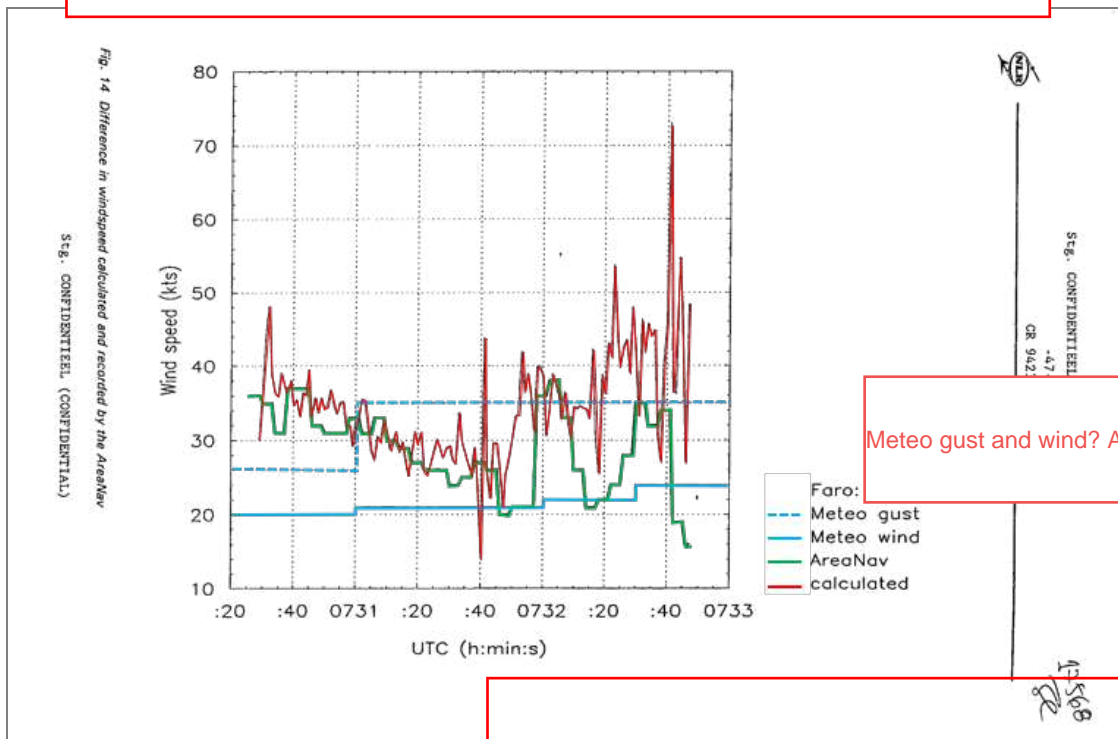
Meteo gust and wind? At the airport, c

Where is the AeraNav data from? And what does calculated mean? Ho

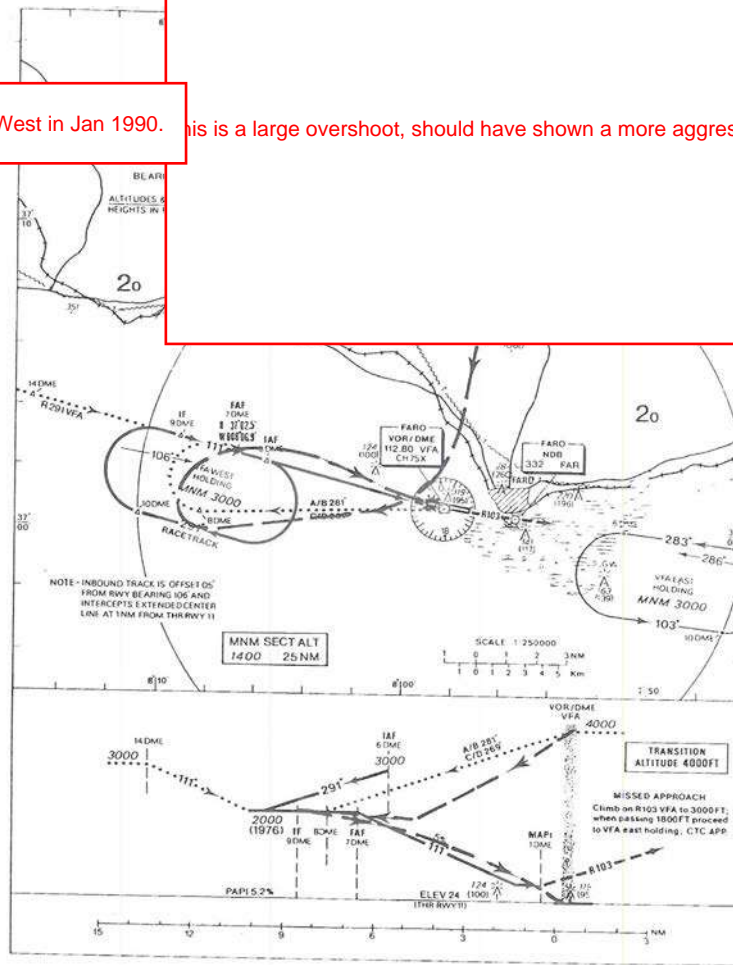
this is a large overshoot, should have shown a more aggressive return to the correct approach rad

In the draft of this report, experts

Was this Annex correct? Did you analyze the control inputs and airca

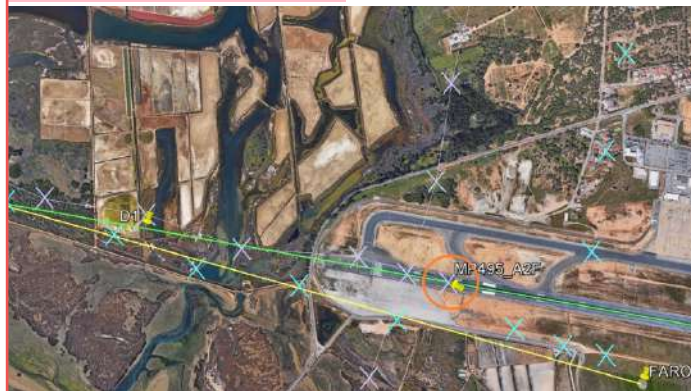
Figure 5: Lateral Flight Profile based on radar data (final segment, zoomed in Google Earth projection) (Purple: Shifted to touchdown point corrected radar track)

In a next step the green track has been again shifted to the west end of the runway (to become a “purple” track) so that the last radar datum (see orange circle in figure 5) is in point of flight MP495.

Experts shift data? Objective?

From this radar data analysis it can be assumed, that the flight MP495 had been laterally aligned with the extended centreline (quite late) shortly after the intersection of VOR radial 111° and the centreline of 106° at around 0,8 [nm] (or 1.500 [m]) from touchdown. Assuming a three-degree glide path of the flight the corrected ground is at 250 [ft].

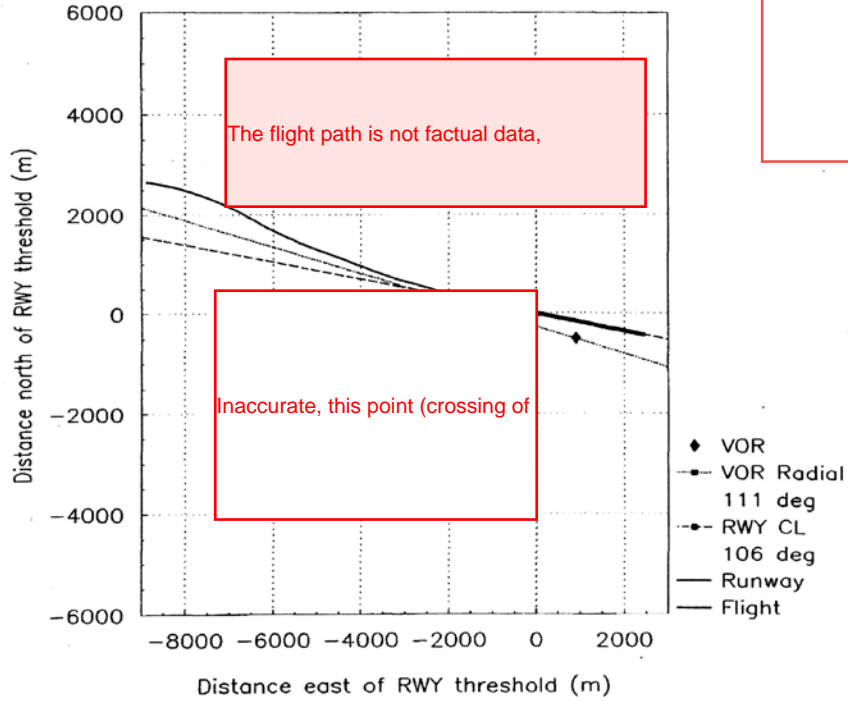
Fig. 16 Lateral flight path - small scale

What is your motivation to write

This figure is out of an NLR re

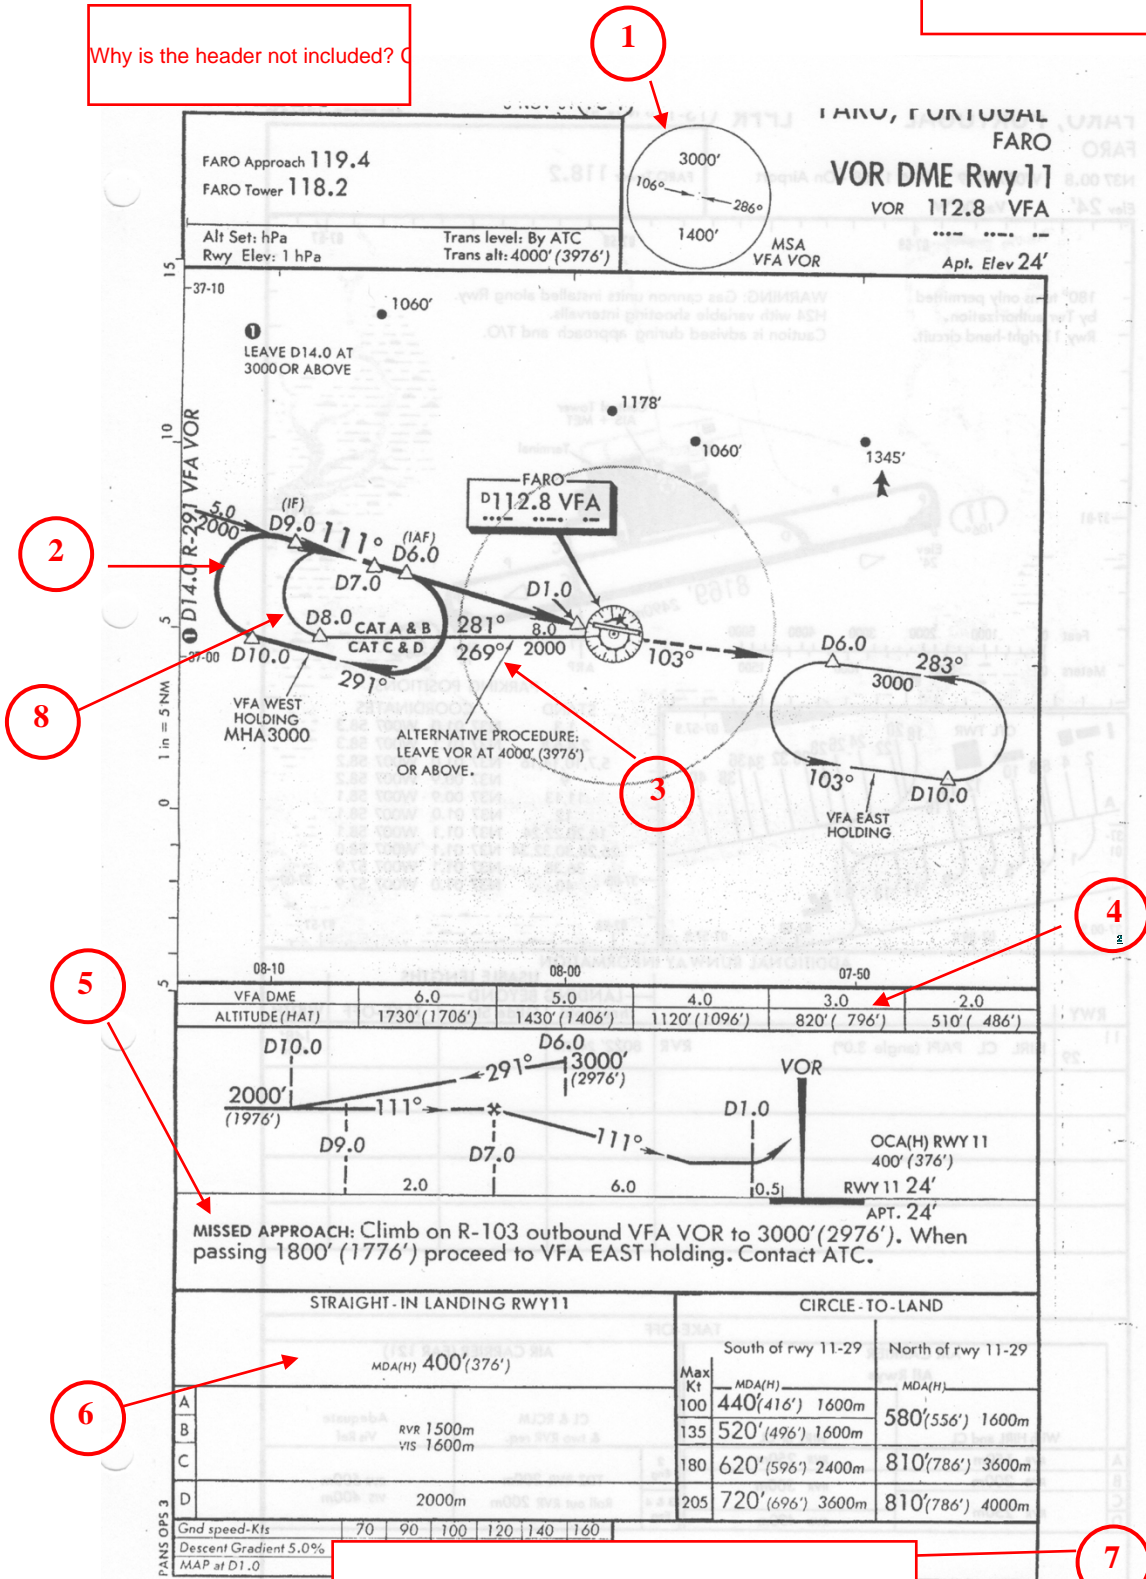
This is not the Approach Plat

Why is the header not included? C

Descent gradient changed from 1992 chart (was 5.2%)

Is not relevant to the case, to the questions asked by
