The Last 80 Seconds of Flight MP495 on Dec 21, 1992

DFDR and AIDS data analyzed in detail

3 August 2017

AvioConsult

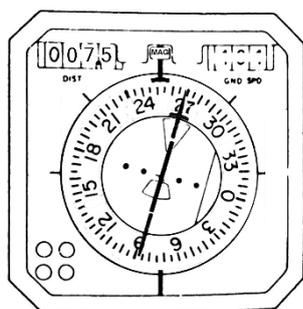
The ATC radar plot in Figure 1 shows that the outbound track was flown quite accurately. DFDR data show that close to the 8 nm point, the airspeed was 170 kt and the heading 252°, proving that a considerable wind correction angle was required at that point ($269^\circ - 252^\circ = 17^\circ$) to compensate for the crosswind component, that must have been approximately 50 kt ($170 \cdot \sin 17^\circ$). A strong wind of which the pilots must have been aware, because they had to manually set the required heading (252°) in the autopilot heading window rather than the outbound radial (269°)

(refer to § 2.5.2). The drift/ wind correction angle was clearly visible, as shown in the adjacent figure. The wind at 8 nm was strong, may be because a thunderstorm was close by.

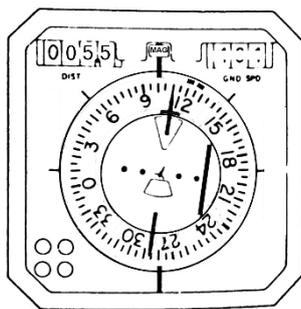
landing too late. At 7.5 nm, the vertical speed should be set in the autopilot, such that the descent indeed begins at 7 nm. The descent will be further analyzed in § 5 below. At 5.5 nm, the display of the HSI could have been as shown in the adjacent figure. The heading set on the autopilot is 125°, the approach radial is set to 111° and the magnetic heading at this instant is 100°. The course deviation bar is maximal right to indicate that the heading needs to be increased (to $111^\circ + 30^\circ = 141^\circ$) for intercepting the 111° approach radial at an angle of 30°. This did not happen.

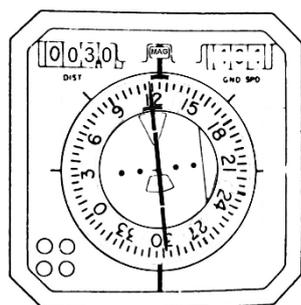
- 4.1.5. Both the ATC radar data in Figure 1 and the analysis in § 5 below prove that no course correction was applied to return to the 111° approach radial, while this is required for the approach to be stabilized, as required in BIM 3.4.4 – 06 and AOM 3.3.5 – 11. The angle between the airplane position and the approach radial at 500 ft altitude may not exceed 2° (1 dot), but was for MP495 even 6° that cannot even be displayed on the HSI. The course deviation bar must have been all the way to the right side as shown in the figure in the next paragraph. The pilot cannot only set the required approach radial on the VHF NAV Control Panel (Figure 2, item 1), but also adjust the course (CRS) knob until the course deviation bar of the HSI is in the middle, to be able to navigate direct to the VOR/ DME from the current airplane position.

This could have happened with MP495, because the ATC radar data in Figure 1 on page 9 shows a near constant (too) large deviation (6°) from the prescribed approach radial, in which case 117° would have been set as direct to radial. At 3 nm, the HSI indications would have been as shown in the adjacent figure. The heading was 125° (DFDR data), the approach radial set to 117°. This angle was measured in the radar plot in Annex 12 of the RoA, that is copied in Figure 1.

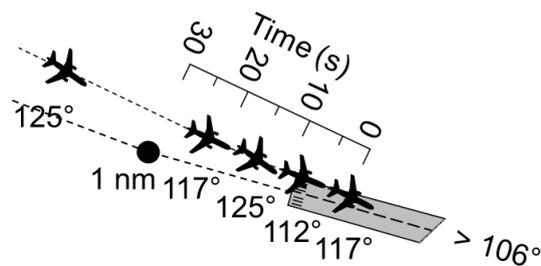
- 5.9.1. **At 33 s**, with about 1.3 nm to go, the copilot again applied left rudder, up to 15% (Attachment 3 ⑤), 7 s later even with two peaks to 30% (Attachment 3 ⑥). The average rudder input was not that large that the heading changed (Attachment 1 ⑭). Attachment 2 ① shows that the rudder peaks are not that large; the yaw damper was also controlling the rudders. In the meantime, the airplane approached the 1 nm point from the runway threshold and could have started to align with the runway thereafter (§ 3.2). This might have been the intention of the copilot by applying rudder input already from 42 s, but then you do not release the rudder under the strong crosswind conditions, but it happened, at 22 s following the second peak (Attachment 3 ⑥). As side effect, and because of a roll control force (Attachment 5 ⑤), the airplane banked 5° to the right (Attachment 3 ⑦), after which the copilot applied left aileron control force to zero bank (Attachment 5 ⑥). The DFDR recorded small rolling movements as side effect of the yawing due to rudder input (Attachment 1 between ⑮ and ⑳), but not a prolonged constant bank angle to the right that would be required to counteract the drift caused by the crosswind and stay above the (extended) runway centerline. These control inputs and airplane motions are not normal if the airplane approaches

on the extended centerline, straight in front of the runway, but support both the conclusion that the airplane approached from the left side on course 117° and the attempt to displace the airplane towards the (extended) runway centerline.

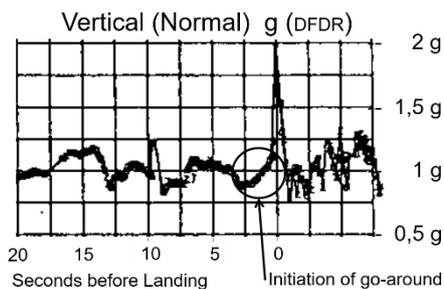
- 5.13.1. During the last seconds of flight, the pitch angle was increased to 9°, with a dip at 2.5 s because the pilot did not maintain control column input up (Attachment 4 (8)) while

the throttles were pushed forward, both for the go-around. These control inputs, including the dip, are shown by the graph of the vertical acceleration (Attachment 1 (28)), of which the relevant part is shown in the adjacent figure. The graph proves that the airplane was not pushed down by a downdraft during the last 2.5 s of flight but that, on the contrary, the descent must have reduced because of the re-

sponse of the airplane to the elevator-up control input for the go-around (Attachment 2 (9)).
